St Bridget's Church, Brigham

Condition Survey and Stage One Report on the Tower

MAY 2012

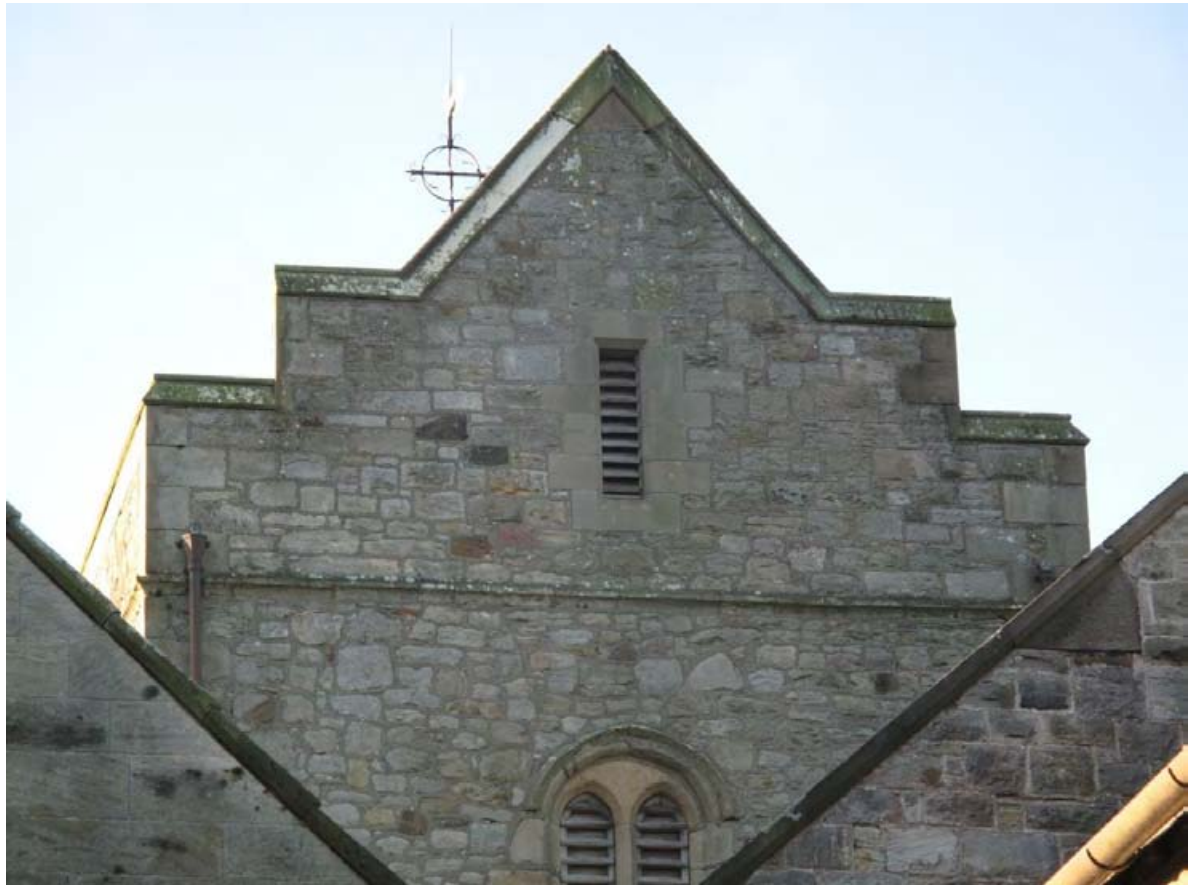
The gutters of the Tower currently drain to two points on the east elevation where small circular outlets, with a right-angle bends, drain into downpipes. One hopper remains on the south downpipe which discharges onto the lead gutter above the Arcade. There is a significant restriction in water flow at the outlet that could lead to blockages. Ideally, the outlets should be redetailed, with sumps and chute outlets, with weired spitters positioned over the hoppers, to reduce any risk of debris blocking the downpipes.

Fig. 4 – East facing gable and rainwater outlets.

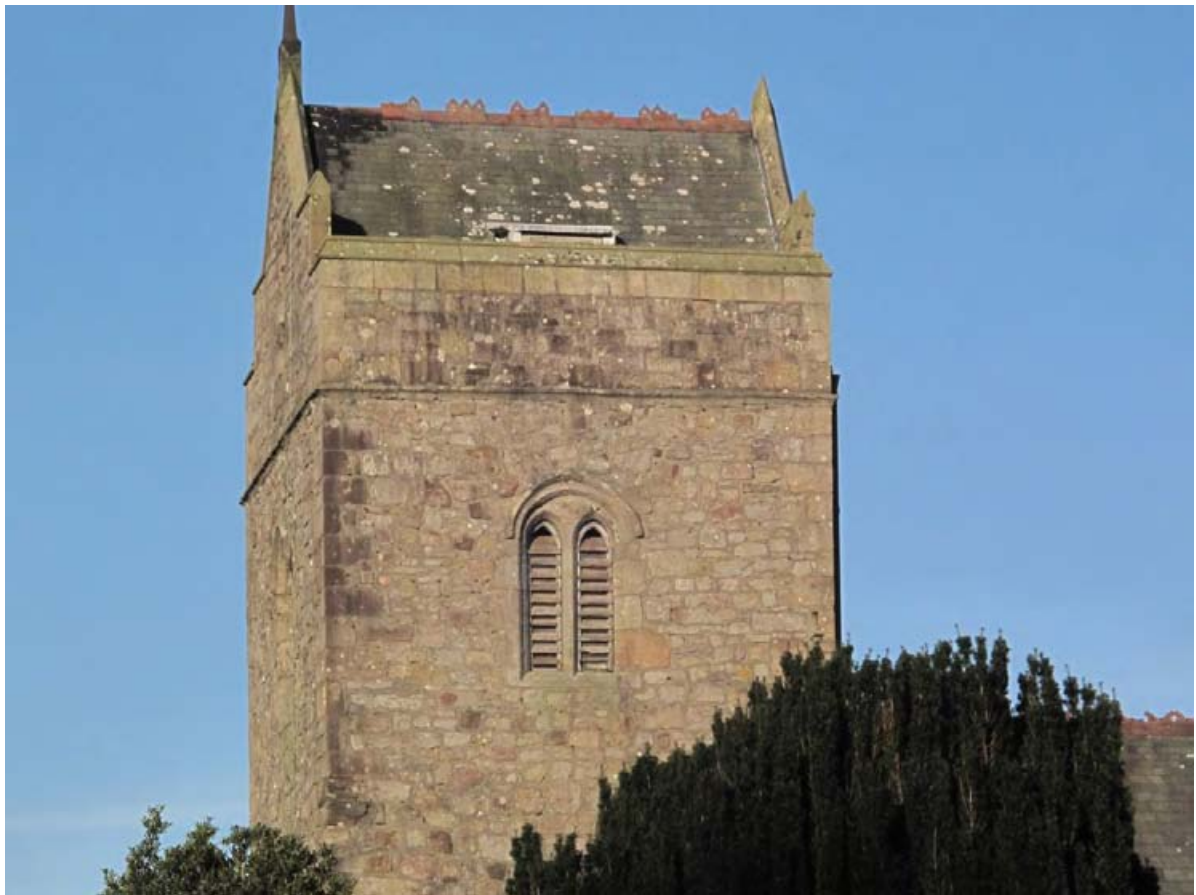
Fig. 5 – South parapet, slated roof and dormer roof access hatch.

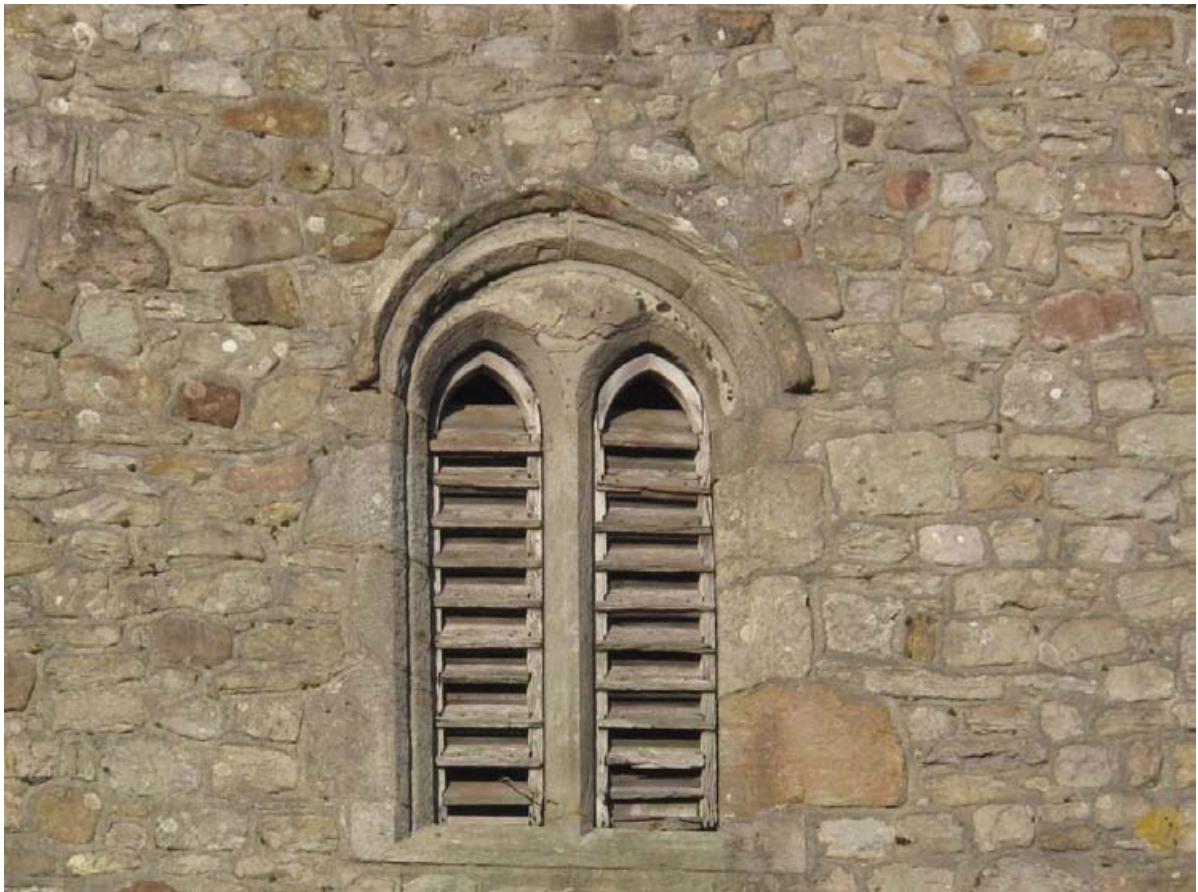
Fig. 8 – South oak bell louvers.

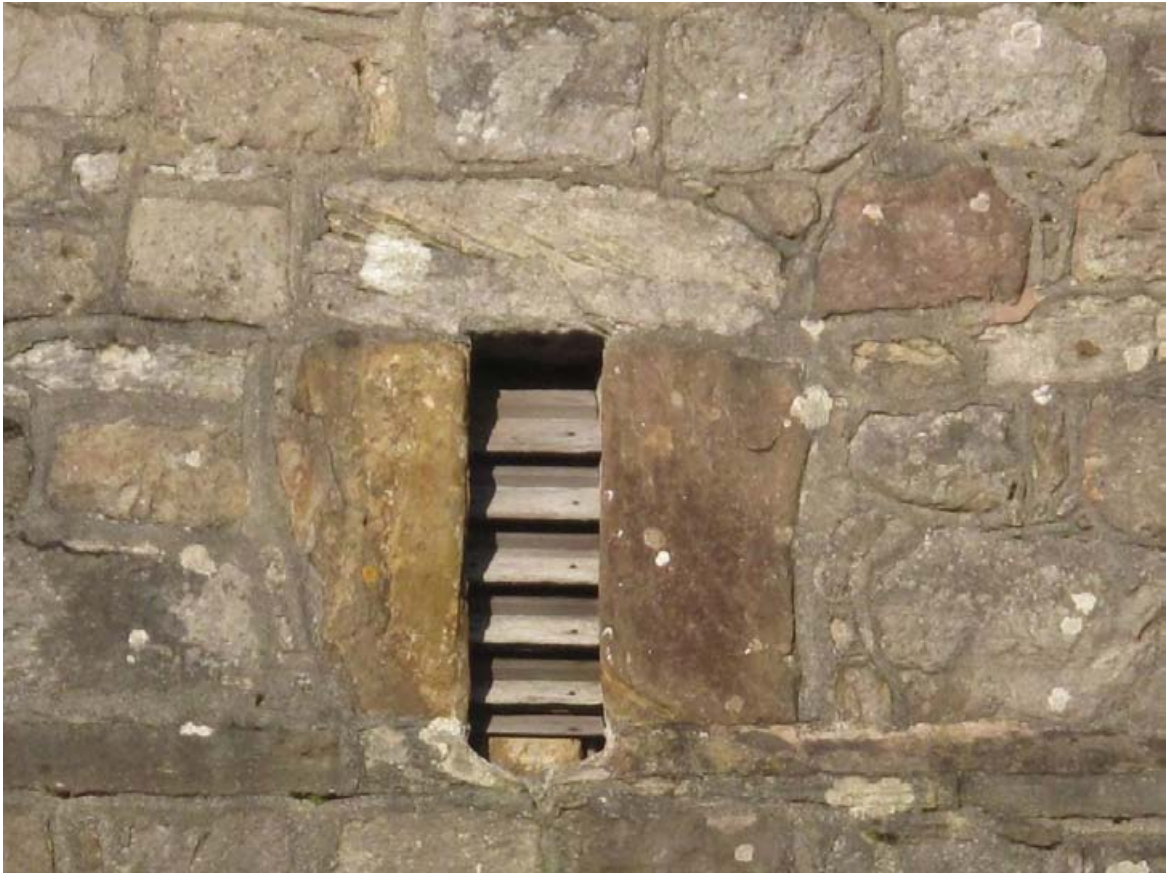
Fig. 9 – Ringing Floor south window with timber louvres.

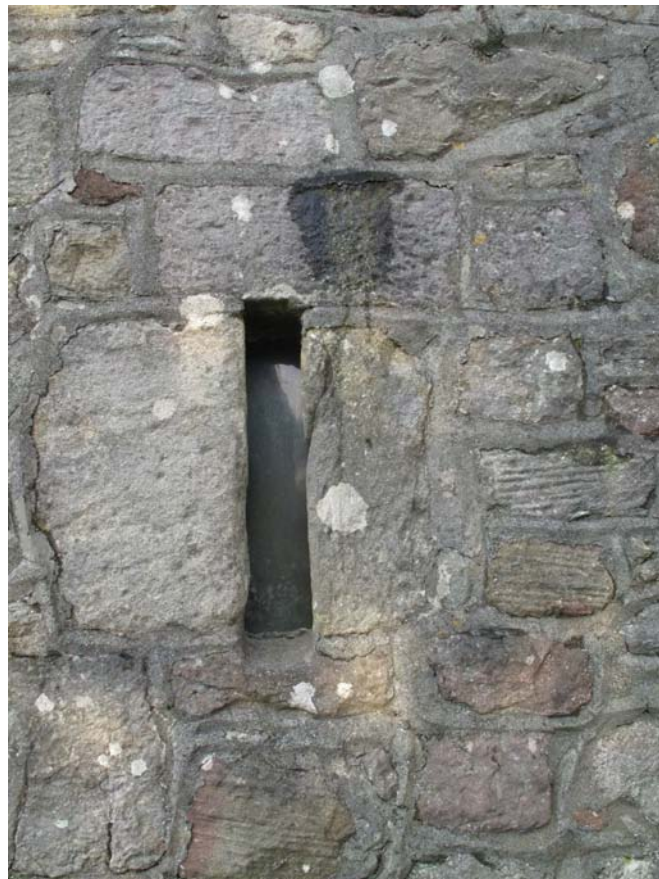
Fig. 10 – South window to mural stair with fixed glazing and profiled overpointing.

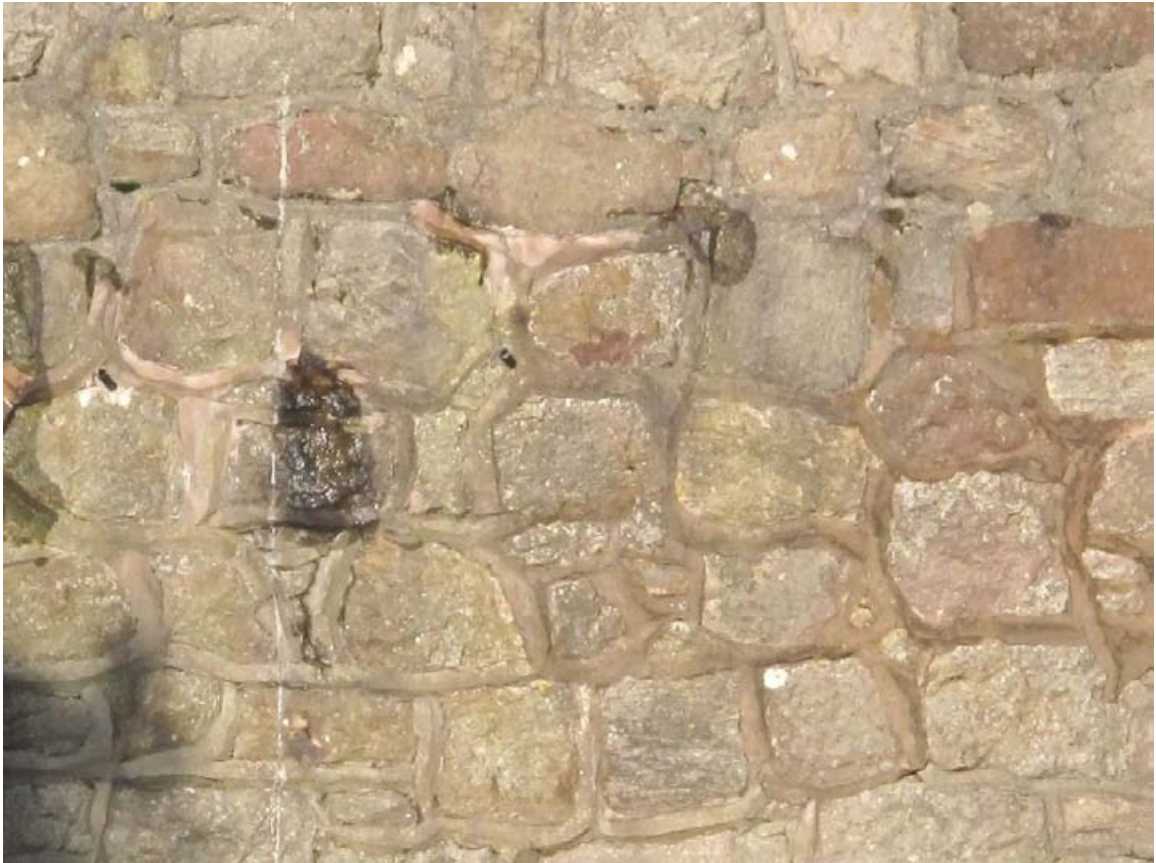
Excessive amounts of moisture in the wall, particularly at the lower level, below the scarcement, is indicative of water reservoirs within the thickness of the wall, drying both inwards and outwards and forming small streams to the outside following rain. It is likely that within the thickness of the wall, approximately up to 1400mm thick, that there are large voids where pockets have formed due to mortar washing out and areas of masonry that have moved. This

provides pockets within the structure where water can collect. However, due to the impervious pointing it cannot escape through the joints.

Fig. 11 – Condition of the pointing with water drying out from reservoirs within the wall core.

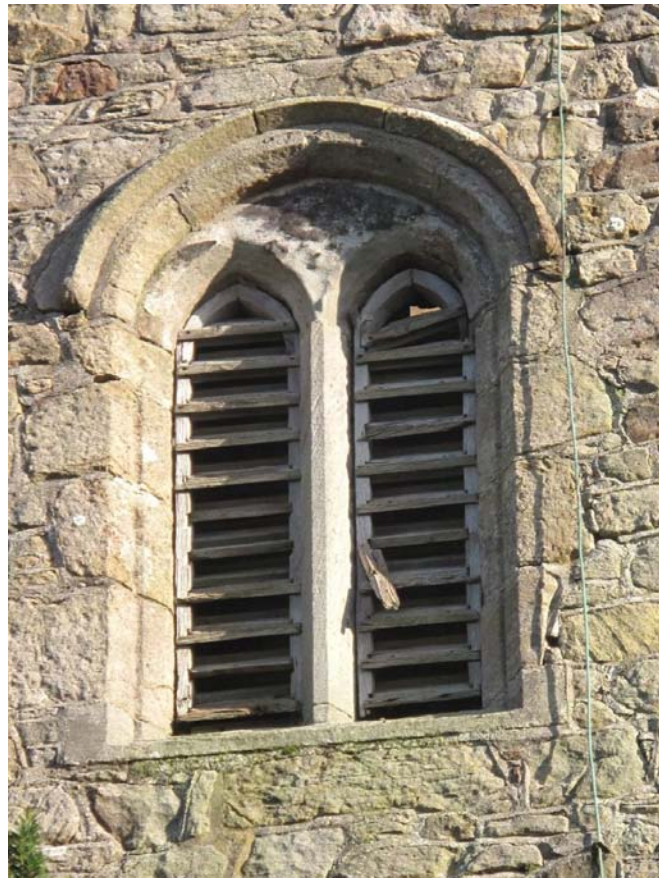
Fig. 12 – Condition of the west oak bell louvres showing their condition and poor fit to the surround.

- j. The Tower is well ventilated from the Belfry level via louvre openings, but these are in poor condition and inadequately detailed, and they should be improved and replaced, particularly to prevent birds entering the Tower;

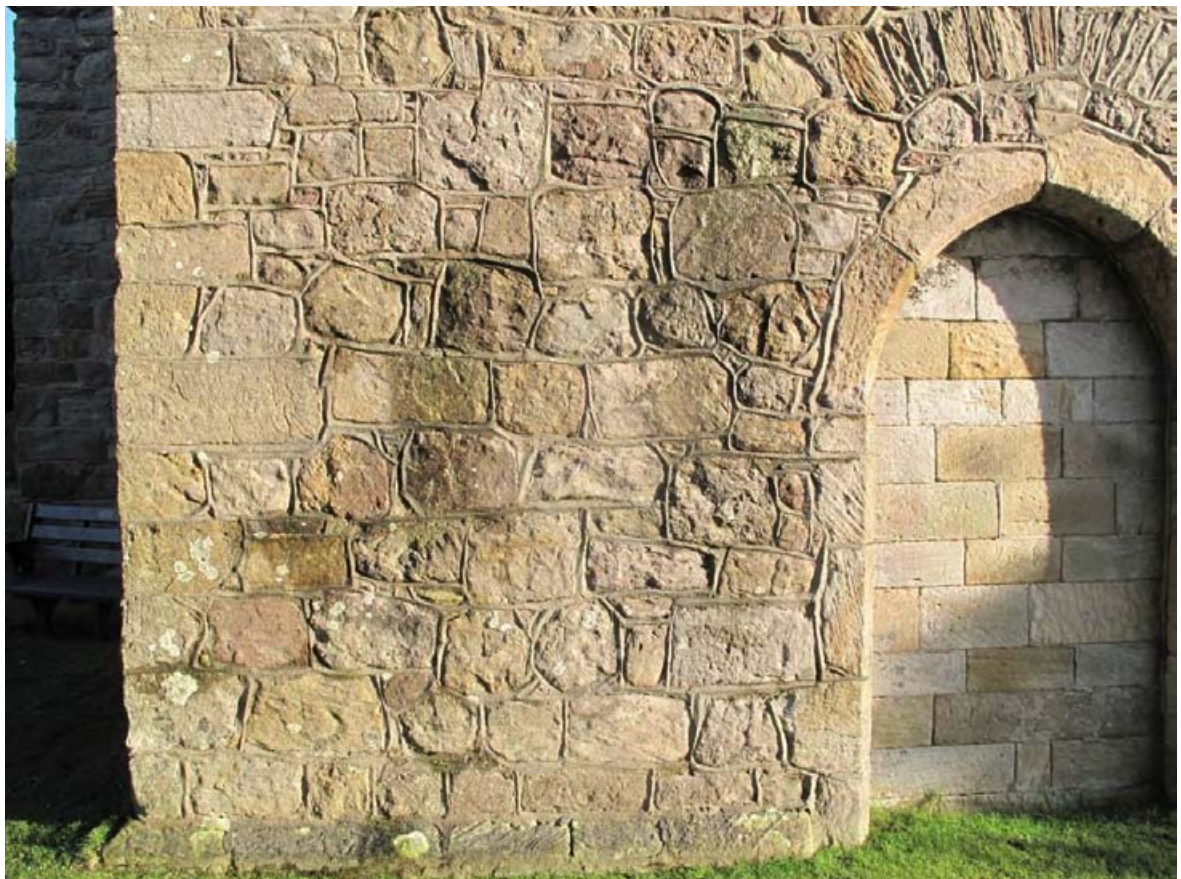
Fig. 14 – Blocked west door and surrounding projecting pointing and damp patches.

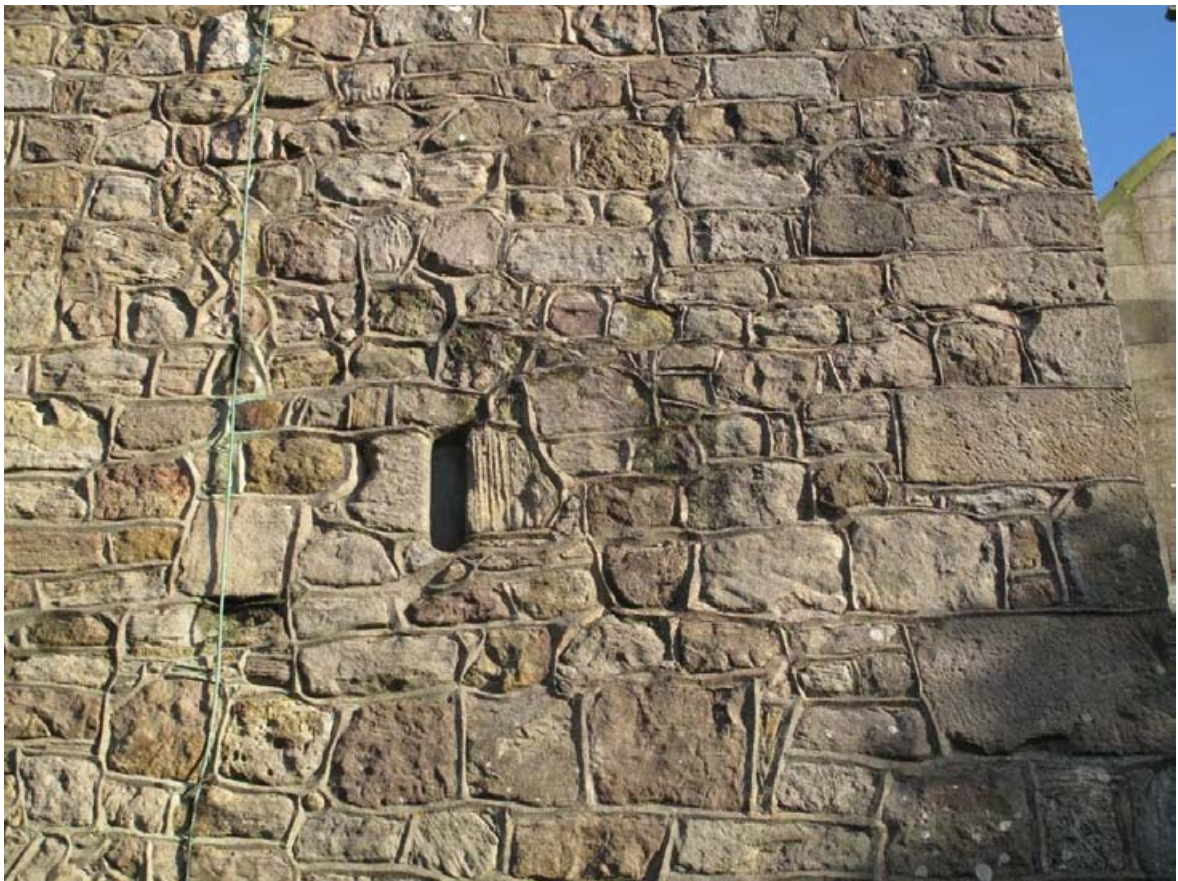
Fig. 15 – West window to mural stair with out-dated and inadequate lightning protection.

- n. Lightning protection is present with one downtape of some age. The cross finial may form an air terminal. Two downtapes are required, as a minimum. Possibly, the Tower installation should be extended to cover the Chancel. A risk assessment should be carried out to current standards and a revised scheme developed if required;

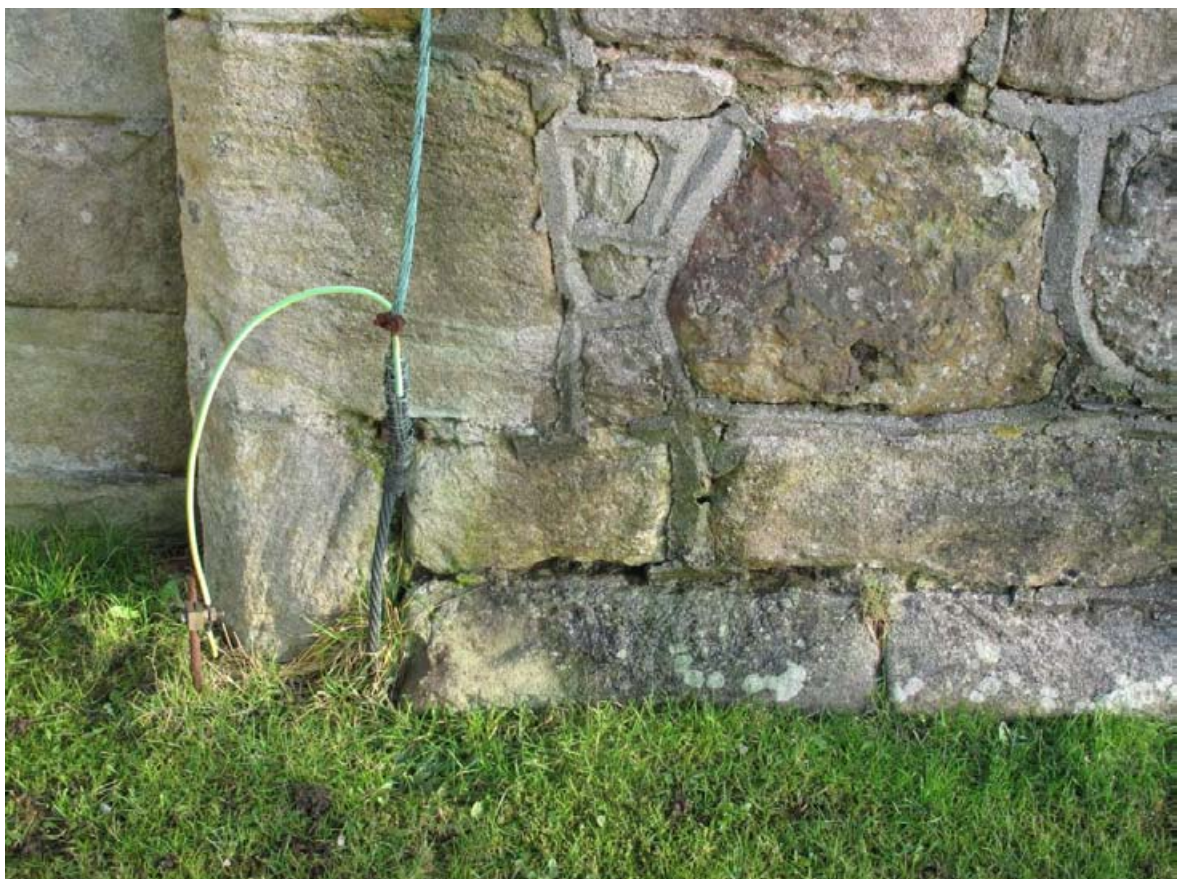
Fig. 16 – Open joints to base of wall and condition of failing cement pointing.

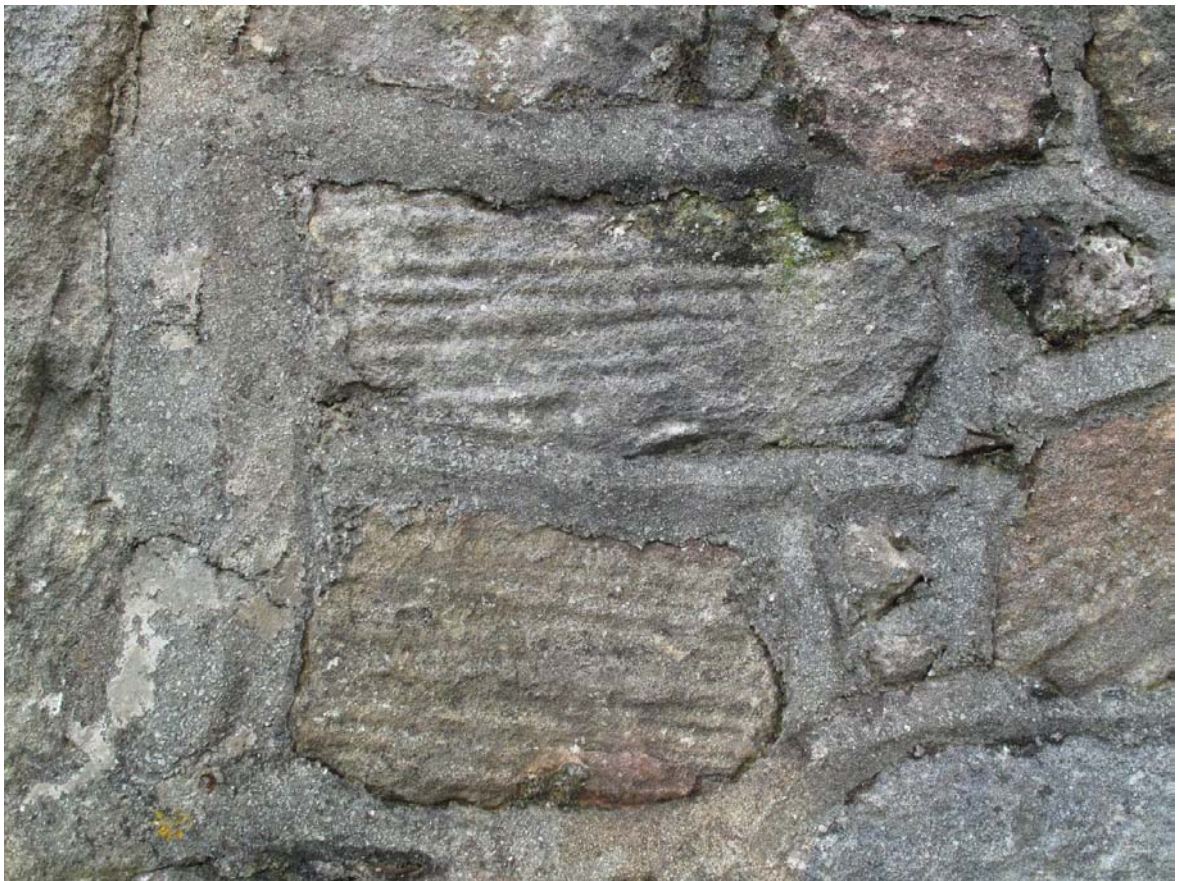
The external walls were once rendered in a fine wet-dash, or harl, which was probably lost in the mid to late nineteenth century, or was simply left to decay since Butterfield's time. It is likely that the render stopped, or was feathered and died at the stone surrounds, with the limewash coats continuing into the reveals and terminating at the glass line. There is evidence of this fine finish across all surfaces of the Tower, but it has largely degraded over the faces of exposed stonework. However, the evidence remains clear as remnants of render can be seen extending beneath the cement mortar overpointing.

Fig. 17 – Condition of the south wall pointing with evidence of previous render.

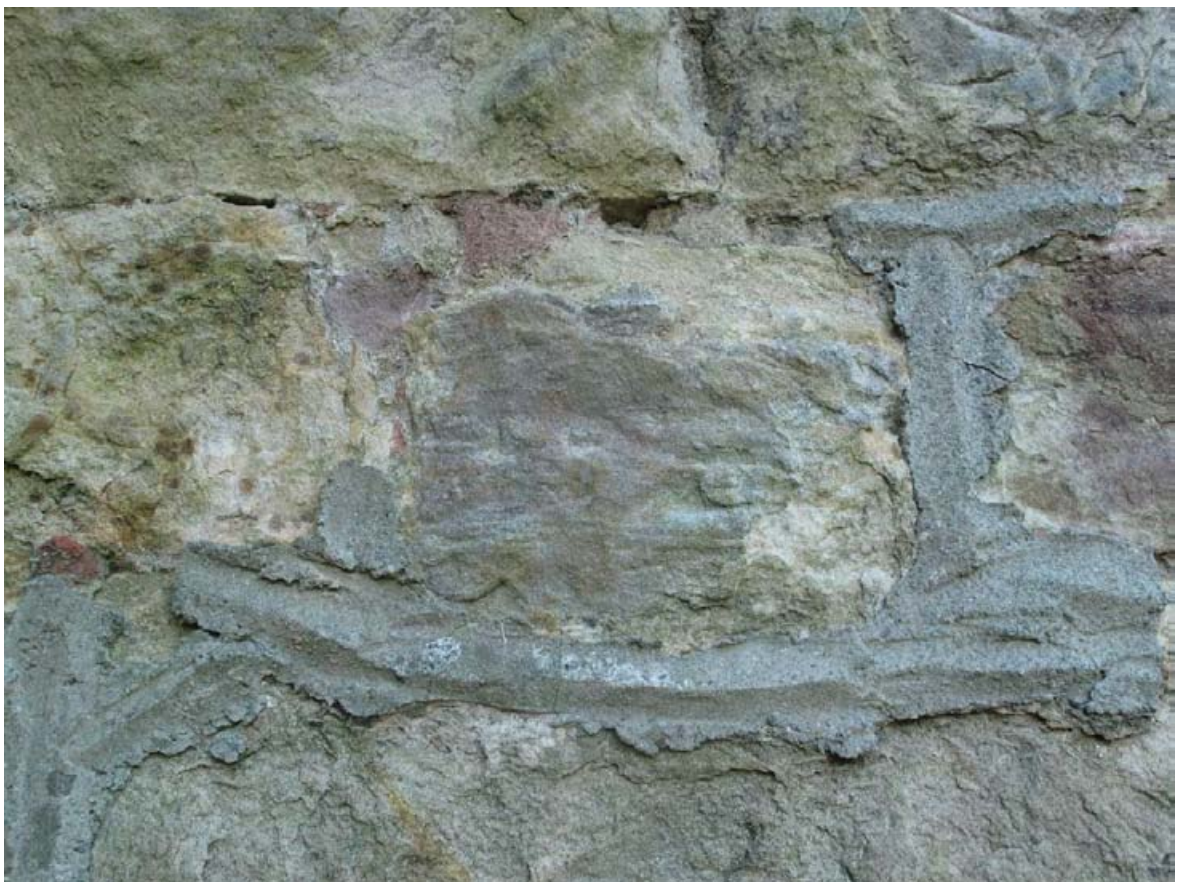
On the north elevation the condition of the bedding joints appears to be quite good, intact and flush, whilst the overpointing is superficial. On the south and west elevations, and probably on the east elevation which could not be accessed, the hard cement repointing appears to be of greater depth. It is evident that the original mediaeval pinning stones were packed very tightly into the joints allowing to be rendered and maintained relatively easily and where they remain this has enabled the wall to remain flush: even when the mortar has degraded few ledges are evident. Where the bedding mortar and pinnings have been removed and the wall is no longer flush, ledges have been created where water can sit and drive into the wall, and these will have to be replaced prior to any future repointing. Across all wall surfaces the pointing is loose and falling away and allowing water to penetrate the walls across large areas.

Fig. 18 – Superficial modern cement pointing on north wall over C19 mortar repairs showing the flush nature of the old joints

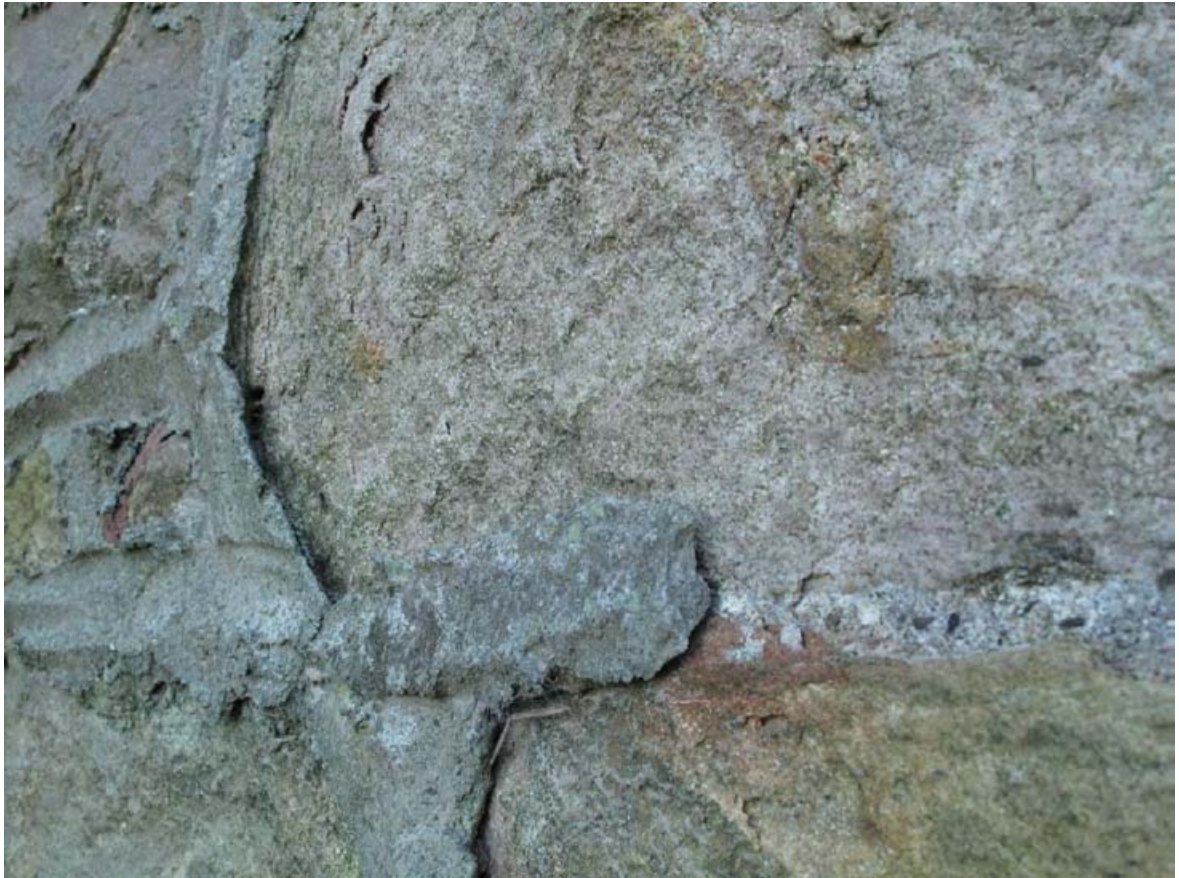
Fig. 19 – Failure of mortar joints over extant, flush lime mortar bedding.

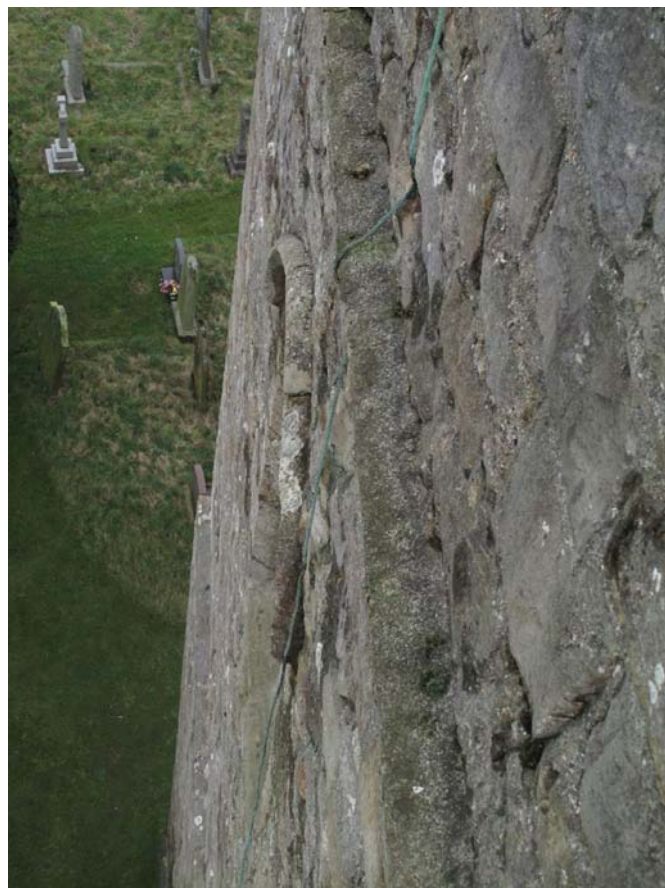
Additionally a drip course below parapet level, indicating where the upper part of the retained mediaeval masonry, forms a break line with the Butterfield work. It has a cement fillet laid on top to throw off the water and this has failed. Moreover the pointing has fallen out from the

Fig. 20 – West wall scarpment with failing pointing and cement filet.

perpend joints along its length allowing water to cascade down the wall; this detail requires deep packing and repointing and possibly a lead flashing laid over.

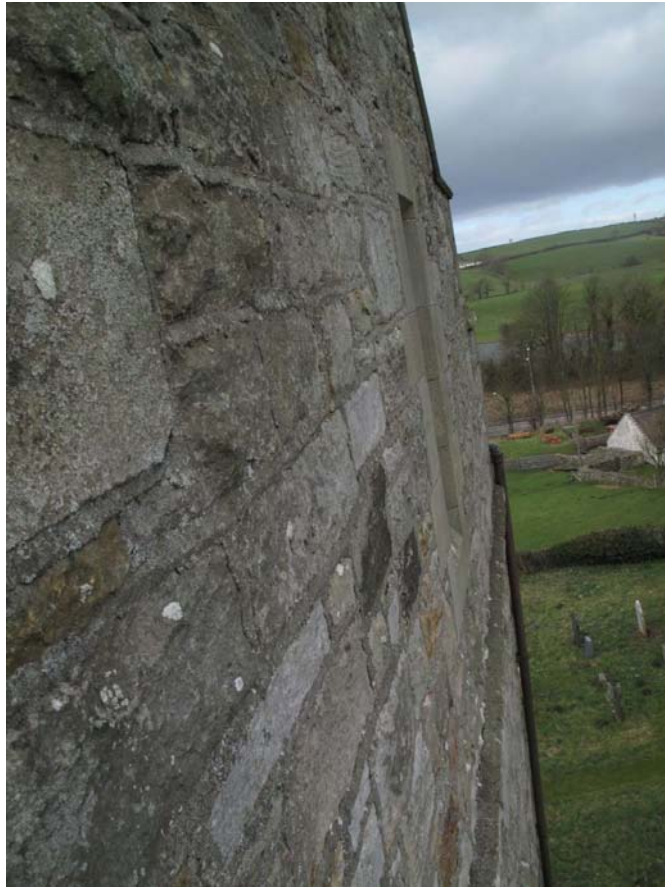
Fig. 21 - Loose pointing and open joints to upper stages of west wall.

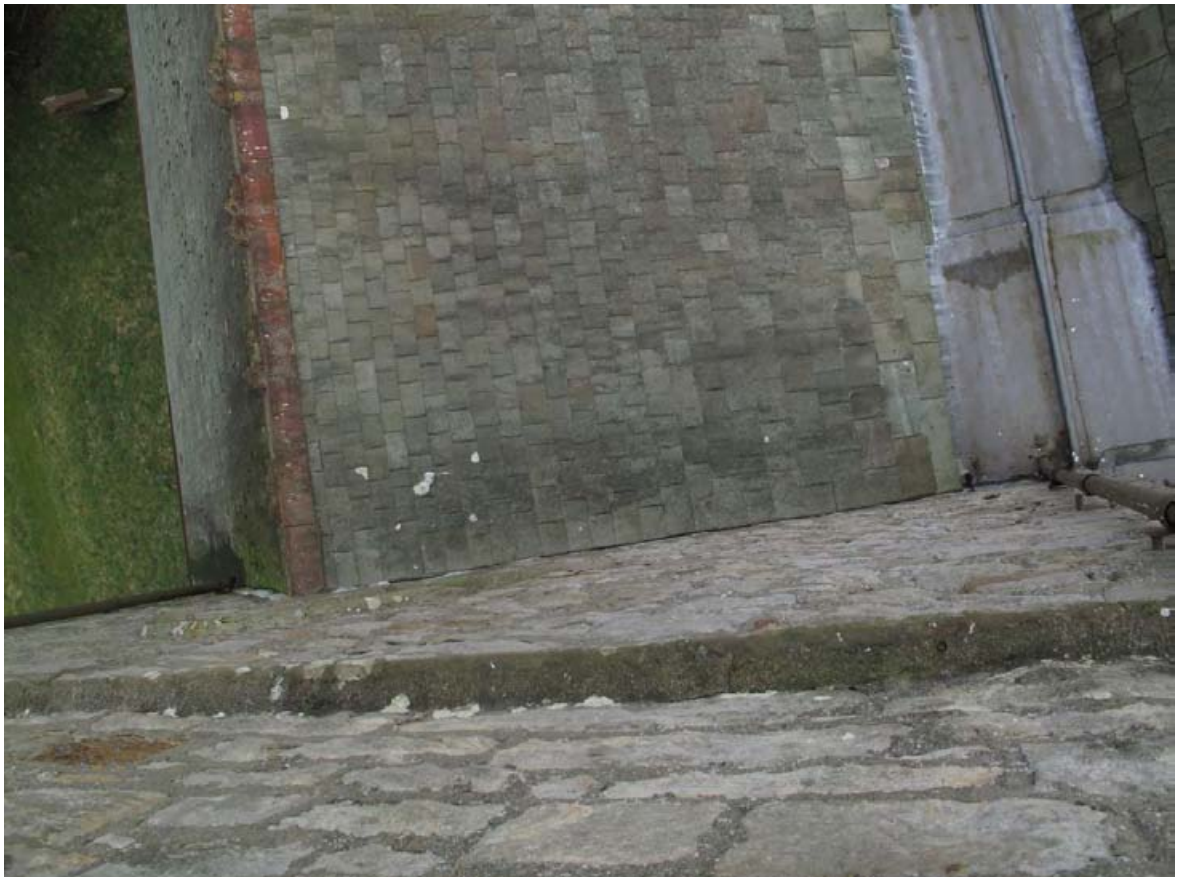
There are some areas of damage to the leadwork cover flashings to the slating at the Nave abutments with the Tower, which are loose, poorly fixed and detailed, and much repaired. This is a vulnerable detail that has failed previously. There is no tray through the Tower wall at this point and it would be impossible to insert one. Discharging rainwater from the northern Tower rainwater pipe increases the vulnerability of this detail.

At the abutment of the Nave with the Tower there is a longstanding water ingress problem. Damage has resulted to the decorated plaster ceilings of the Nave and South Aisle, and to wall plaster below, and this continues despite repairs having been implemented at various times, including repointing and the addition of deeper flashings.

Fig. 22 – Condition of the east wall and abutment with the Nave roof.

By repointing the east wall of the Tower and re-detailing the leadwork and slating at the abutments, while directing run off away from the wall, improvements to the interior condition are possible. However, elimination of the damp conditions entirely may not be achievable. Additionally grouting above this area may provide further defence.

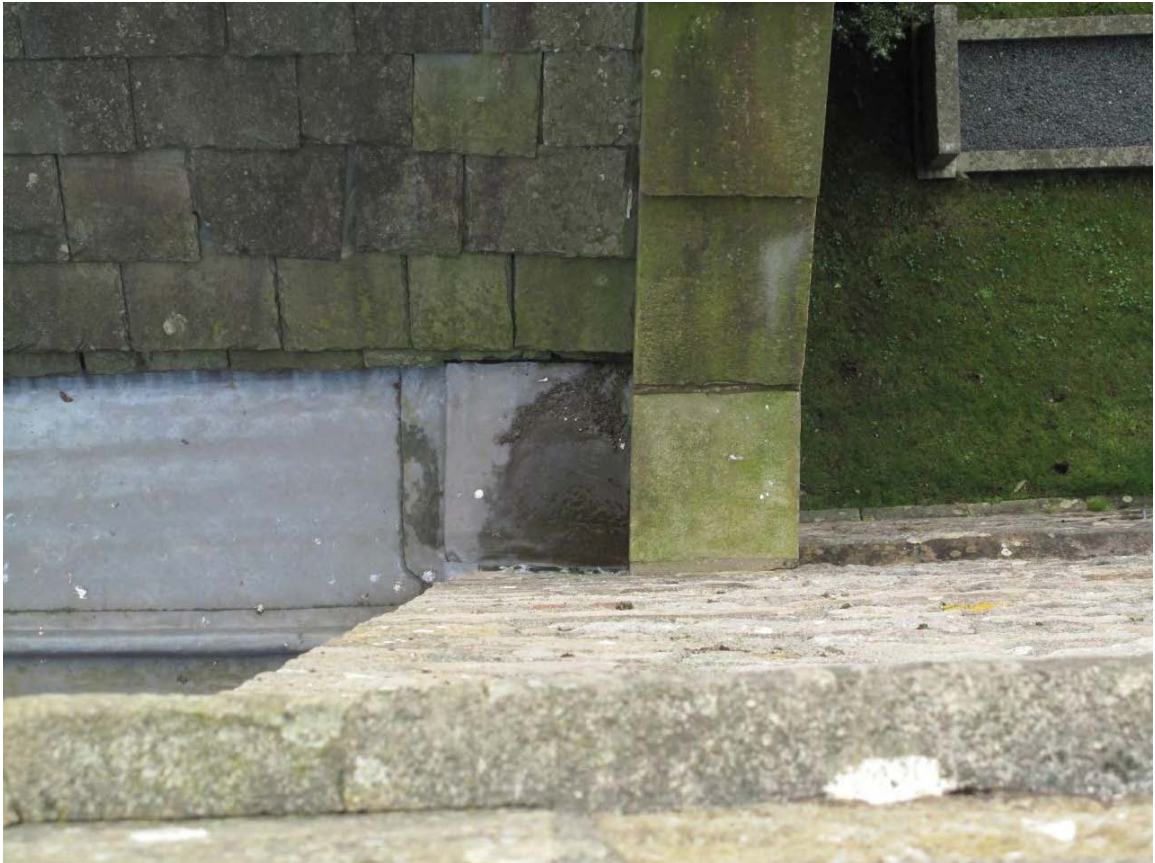
- h. The south rainwater pipe discharges onto the Aisle lead valley gutter and a lack of fall and inadequate detailing has led to pooling, and this should be investigated and rectified;

Fig. 23 – View of the abutment with the South Aisle gutter with pooling at the west end

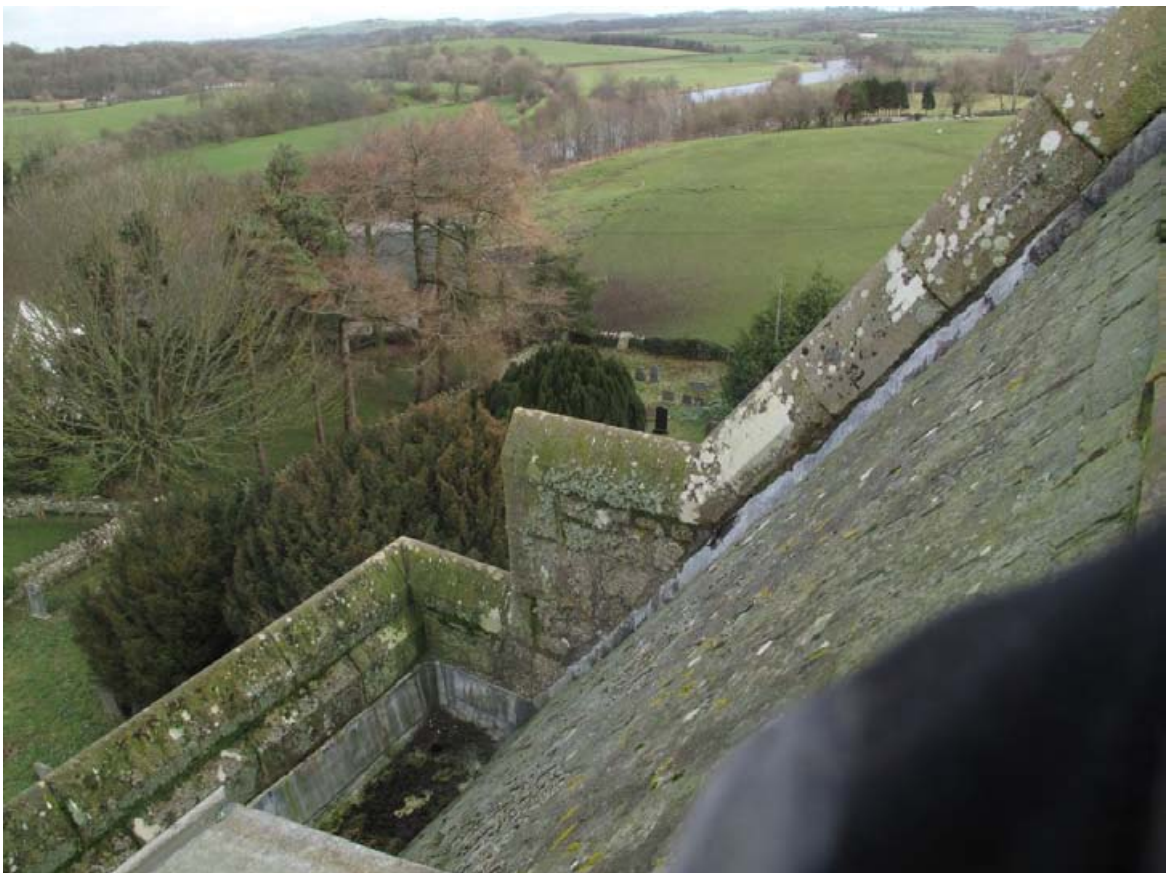
Fig. 24 – The north parapet gutter east flashings, copings and parapets.

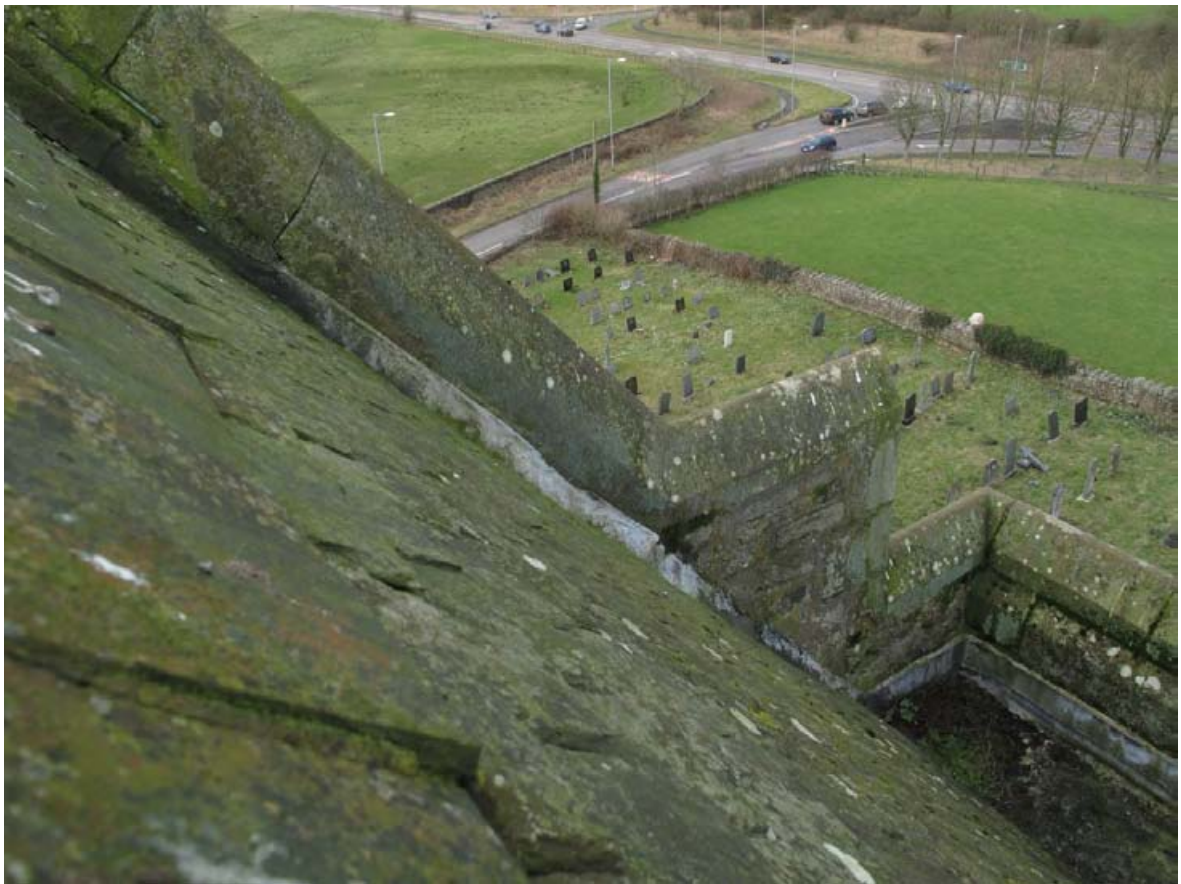
Fig. 25 - The north parapet gutter west flashings, copings and blocked gutter.

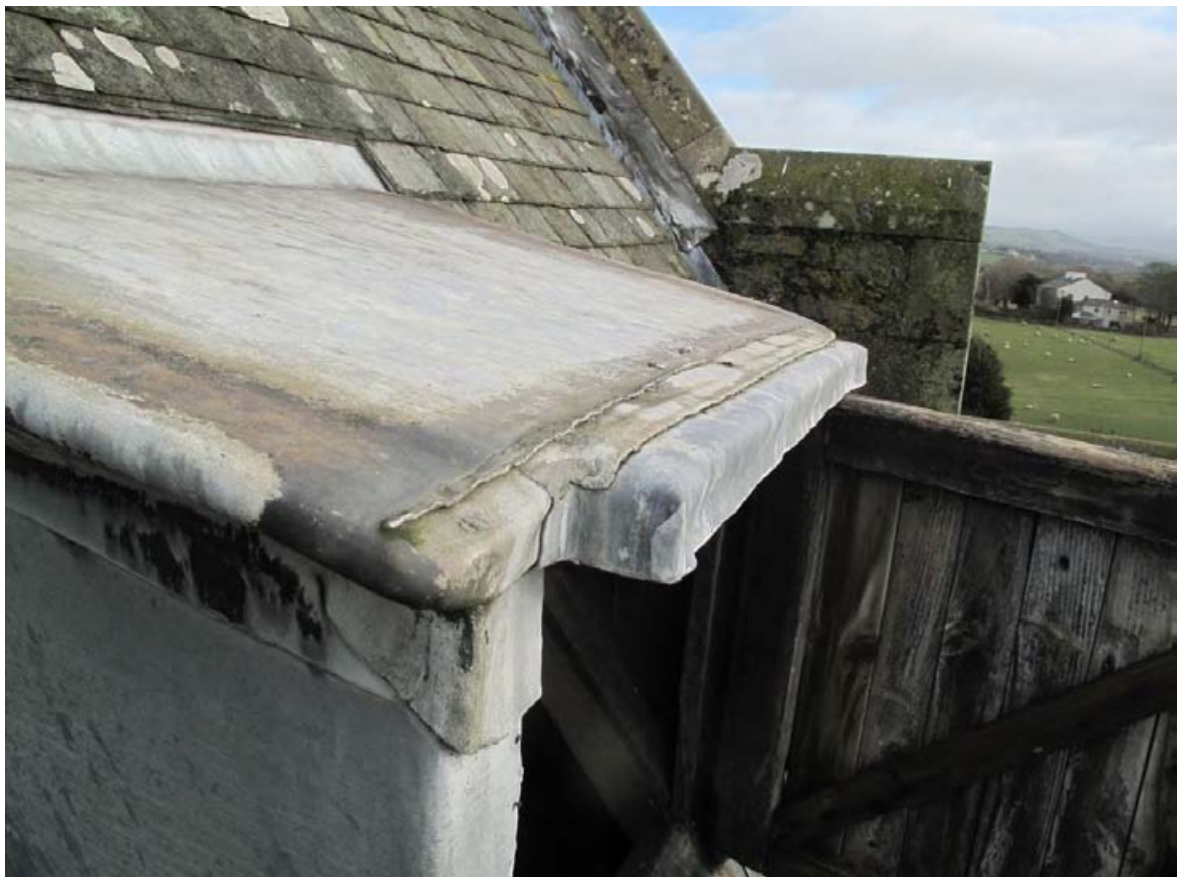
The detailing of the lead-clad dormers is of some age and the flat roofs in particular are badly detailed with a single flat sheet of lead laid in one piece across the top. A later drip mould detail has been added over the door itself for protection. Ideally the roof should fall backwards towards the slating and away from the door. The cheeks are single sheets of lead and should

Fig. 26 – Condition of the south access dormer leadwork and patched leadwork flashings to copings.

be appropriately detailed with wetted joints. The dormers are likely to require relaying completely with new leadwork.

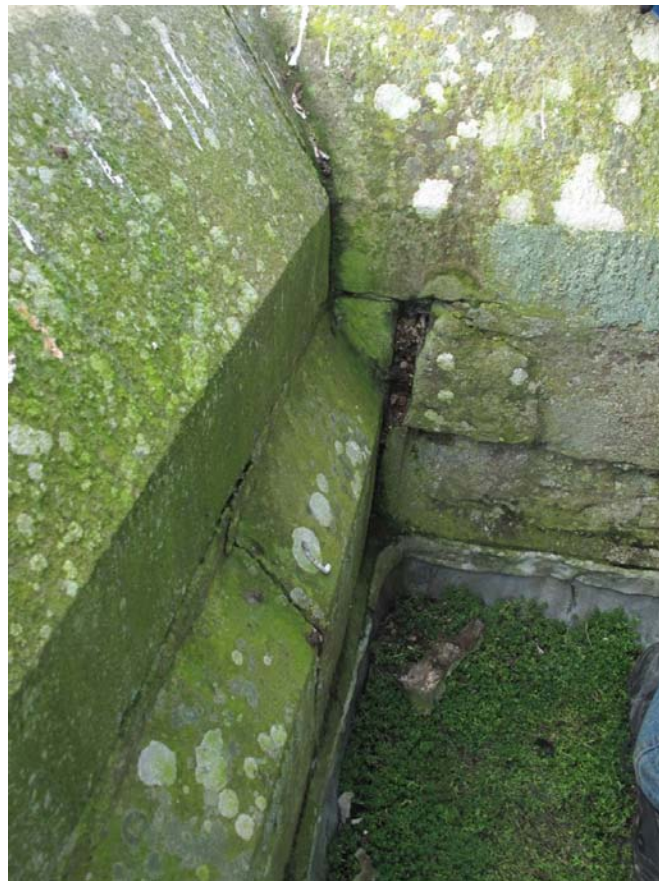
Fig. 27 – Cracking and open joints to parapets at the south west corner.

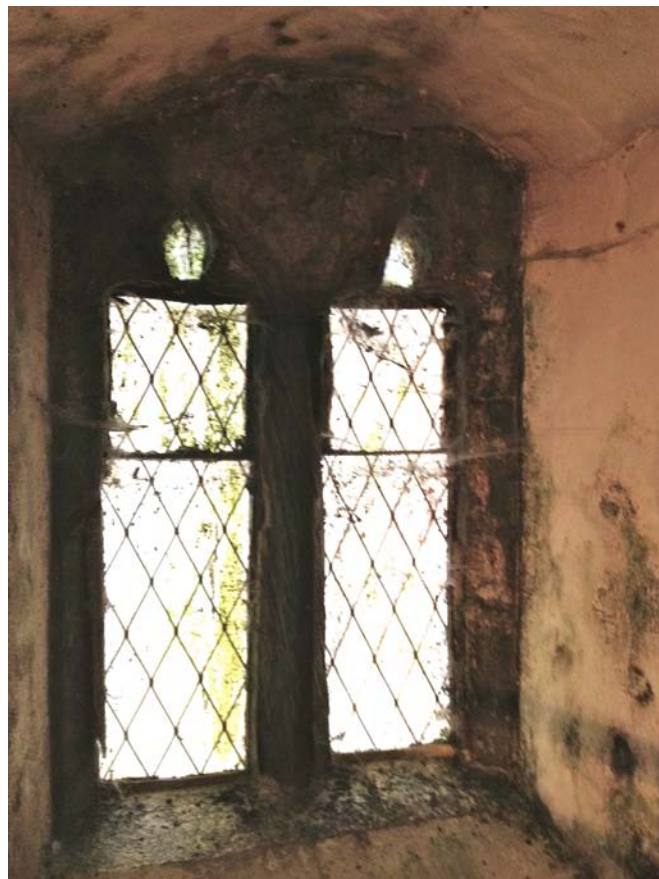
Fig 28 – Condition of the high lancet window to the vaulted chamber.
