St Bridget's Church, Brigham

Condition Survey and Stage One Report on the Tower

MAY 2012

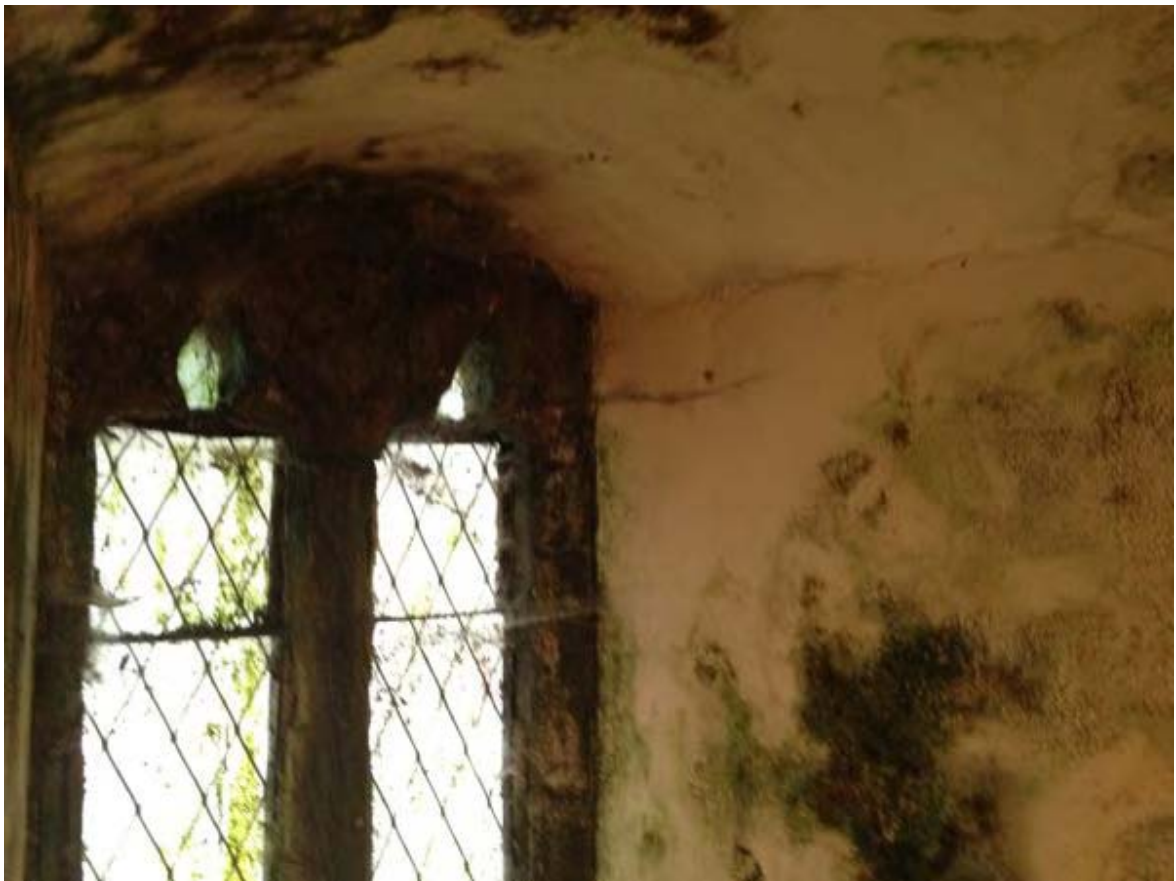
In addition, the west window is suffering from damp penetration at the soffit and to the reveals, and the condition of the stonework mullion and surround is poor and decayed and may require some stone replacement internally. The glass is relatively modern and it is likely that a previous opening light has been lost in this location. It is recommended that this be replaced with a simple opening hopper ventilator, operated from the ground, to provide secure background ventilation.

Fig. 29 – Damp conditions to window reveal and plaster failure.

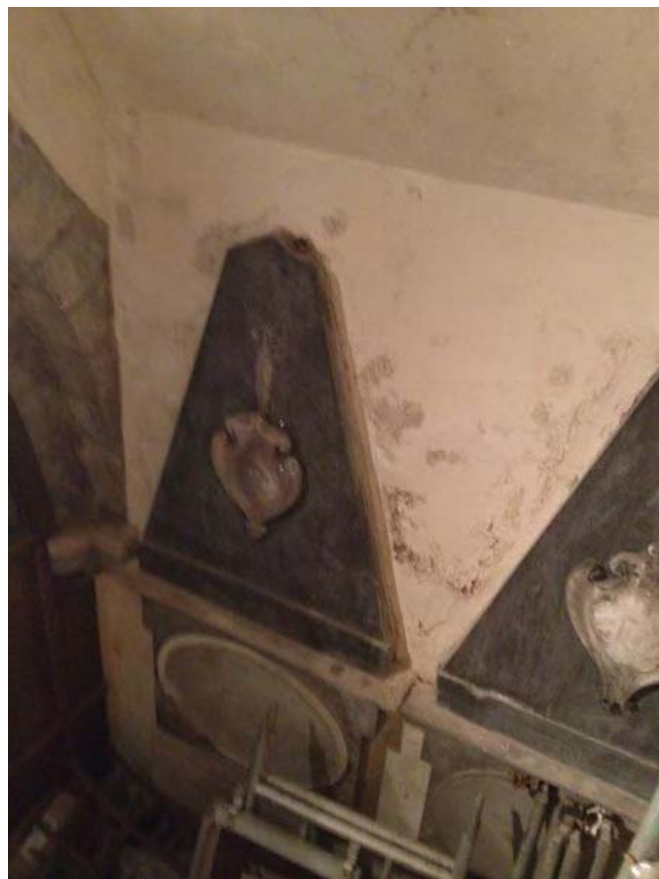
The condition of the Tower ground floor plaster is poor and cracking is evident across all walls, and especially the ceiling, and measures have been taken to remove loose areas and areas which have been patched, again, in inappropriate materials. The ceiling plaster is loose in areas, and it will require replastering completely within the next two years.

Fig. 30 – Plaster failure to ground floor surfaces and monuments.

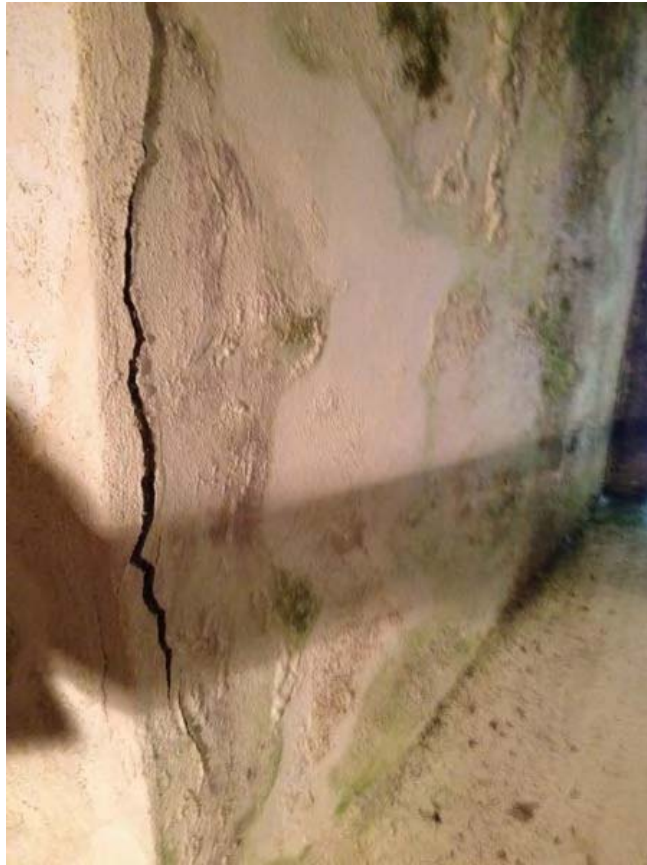
It is believed that the area was replastered approximately twenty years ago using a three-coat plaster specification provided by the Diocese. This appears to have failed, and the likely reason is that the mortar mix is too weak, there is insufficient lime binder and the type of sand used is too fine. In addition, the type of paint applied is a modern impermeable emulsion, which is lifting from the wall due to the dampness and is taking large chunks of plaster skim with it.

Fig. 31 – Plaster coats de-bonding from backing masonry due to high moisture levels and incorrect specification.

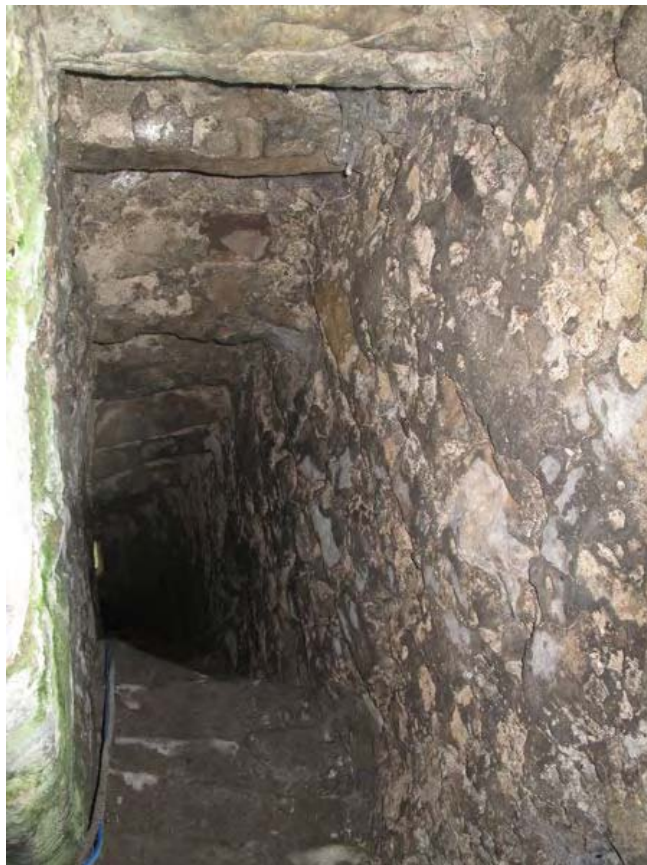
A large mural stair rises from the ground floor to the Ringing Floor in the southwest corner of the Tower, resulting in a drastic thinning of the masonry at this point that has led to the attendant damp penetration problems. The mural chamber is lit dimly by three small openings, currently glazed and which no longer provide ventilation. The entire area is extremely wet with penetrating damp evident where the treads enter the wall and also at the slit openings and across the wall surface. A full measured survey has not yet been carried out but it is believed that external walls at this point are less than 400mm deep. They may even be constructed of one single skin of masonry thus enabling penetrating rain to drive through the joints unless they are fully protected by deep packing, consolidation and repointing externally. The wall should be solid, fully filled and grouted.

Internally lime plaster coats have been lost from the mural stair and the condition of the pointing is also poor, probably due to permanently damp conditions. The walls should be deep packed, consolidated, flush pointed and limewashed to provide a moisture sink, and to increase reflection and light levels.

Fig. 32 – The mural staircase in the south-west corner with failed plaster finishes and water ingress through the outer walls and soffit.

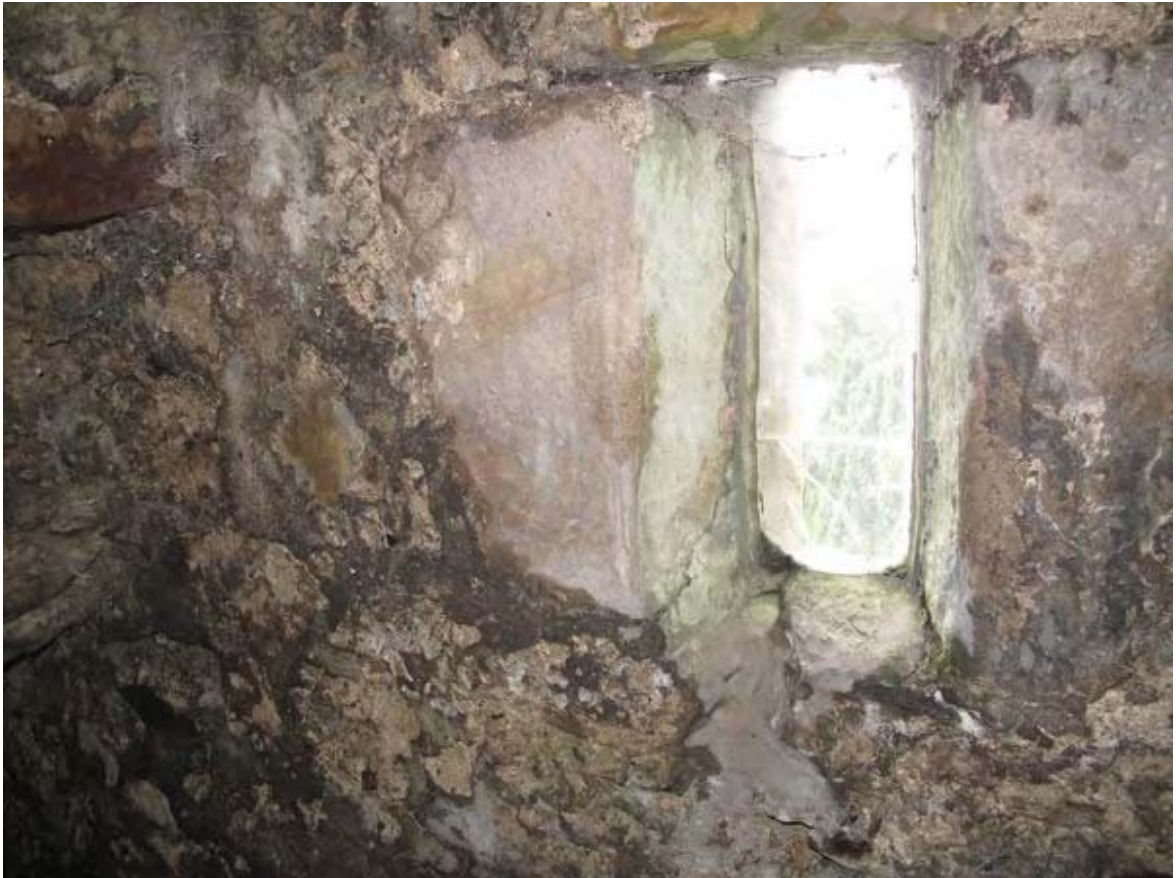
Fig. 33 – Fixed glazing to upper slit window with cement and mastic repairs.

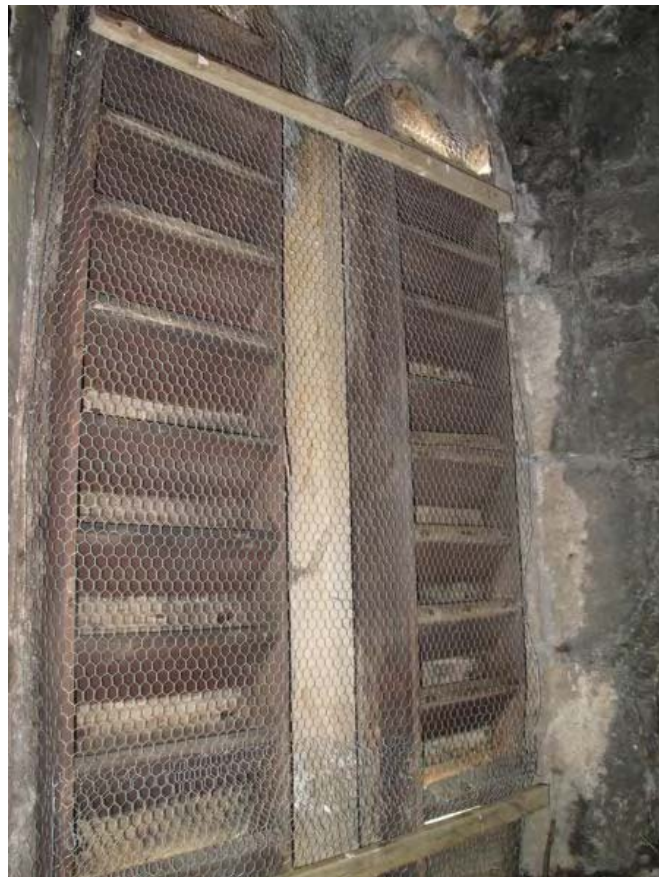
Fig. 34 – Condition of Belfry louvres and bird guarding.

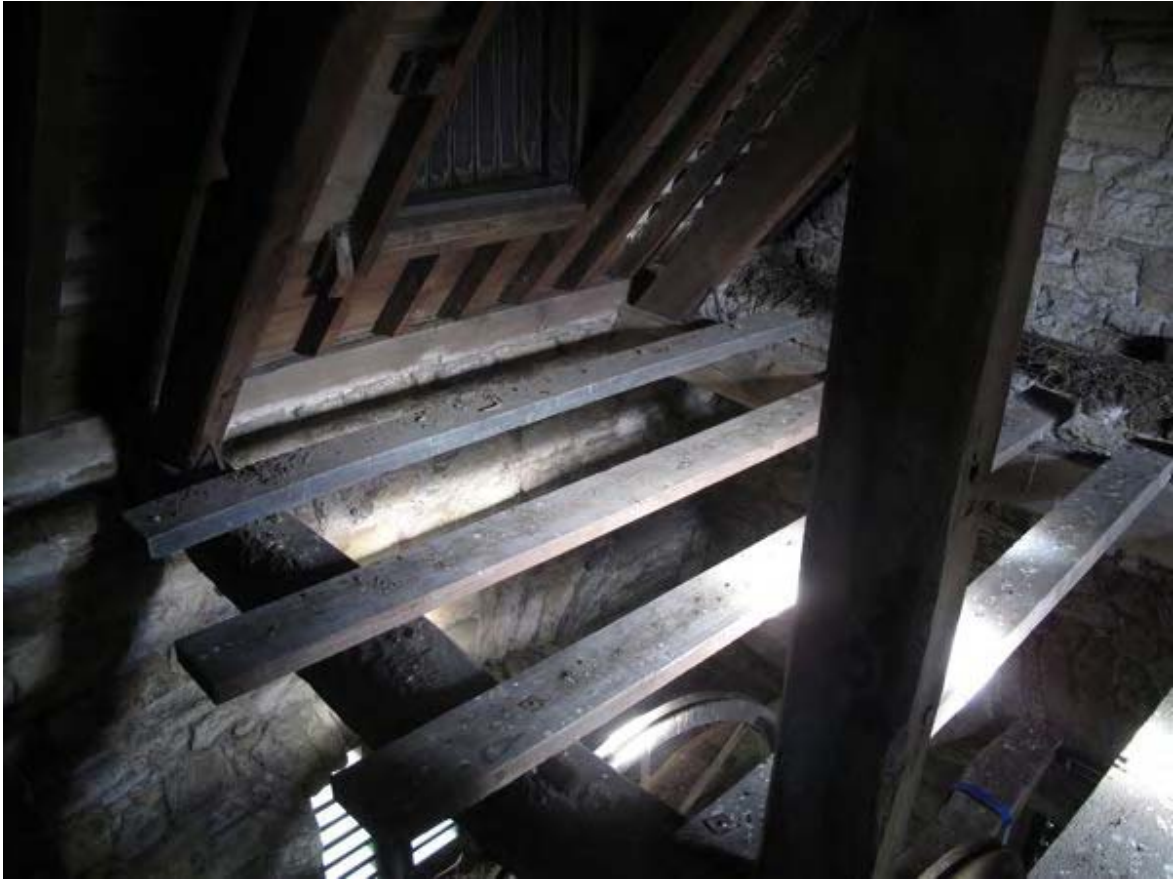
Fig. 36 – Inadequate access provision at roof level.

- l. Lack of safe access in the Tower upper stages from the first floor has been the cause of much of the lack of maintenance at roof level. It is suggested that a full scheme of safe access should be developed. (A similar scheme has been provided at St John's, Skirwith);
