**Condition Assessment and Treatment Recommendations for the Nave  
and South Aisle Ceilings**

**St Bridget's Church, Brigham, Cumbria**

**Diocese of Carlisle**

**July 2012**

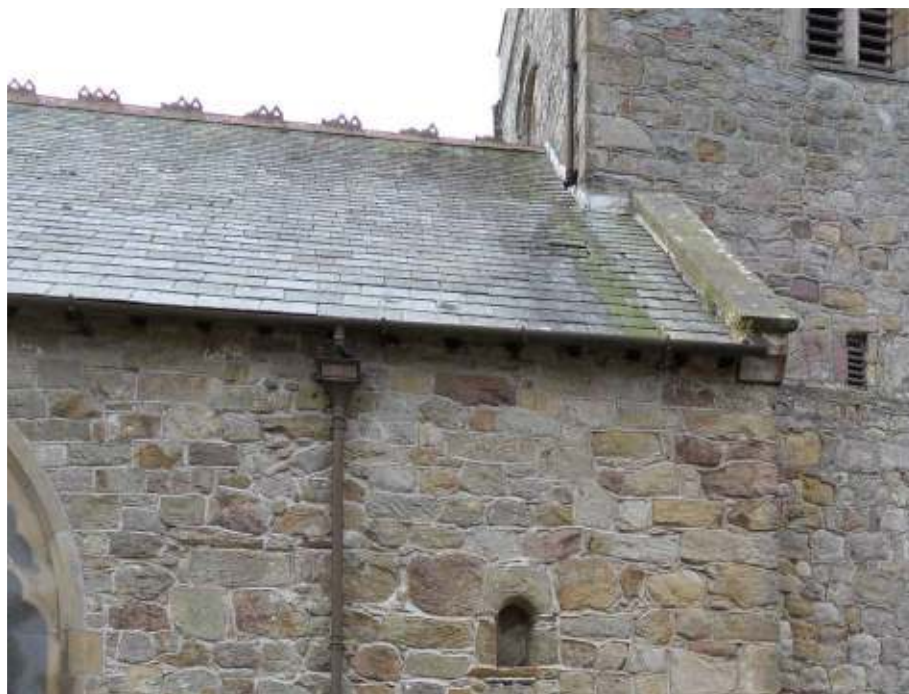
Most areas of the slate tiled roof appear to be in a generally sound condition; some lead grips and wires are evident on the west side of the south porch, holding some tiles in place, and there is a broken tile to the lower west side of the vestry roof. The lead flashing also appears to be in relatively good condition; some areas of replacement cement flashing were noted to west end of the nave roof, north side (see figure 11). In addition, many of the decorative ridge tiles have lost the upper sections of moulding.

**Figure 11.** Detail of north-west corner of nave roof, showing lost detailing to ridge tiles, cement flashing, mildew and grass growth.

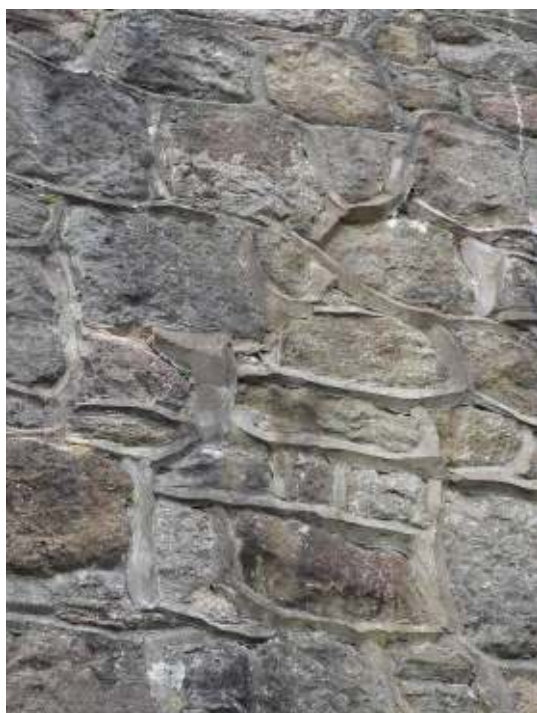
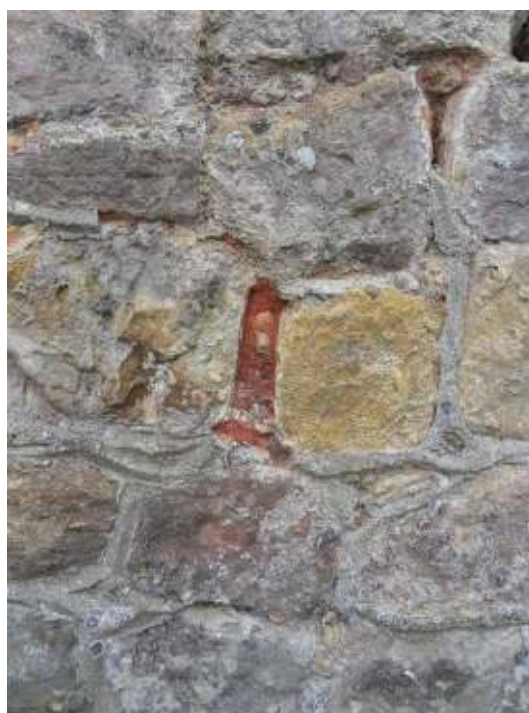
There is extensive re-pointing to the north side of the nave and to all faces of the tower, figures 12 & 13. There appear to be at least two phases of repointing, one of which is cementitious. The later re-pointing is failing in several areas, particularly on the north and west faces of the tower, where a pile of pointing and disaggregated stone work can be found on the ground. The surface of the stonework in this area is particularly weathered. The prevailing winds come from the west, buffeting the tower with driving rain.

**Figures 12 and 13:** Details of extensive repointing to tower, west face (left) and north face (right).

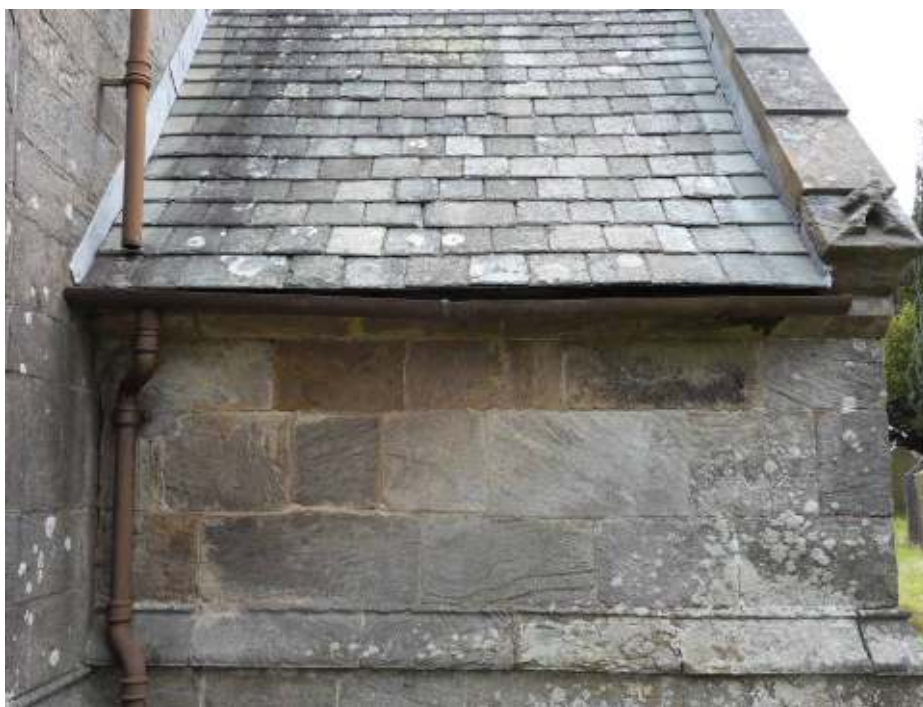
The gutter on the west side of the porch has split slightly (figure 14) and the gutter to the east side of the vestry has dropped at the end. There is a lot of white staining and flaking paint to this section of guttering, suggesting it blocks and overflows regularly. There is small overflow pipe about 2 ½ feet above the ground coming out of the north wall of the vestry (see figure 16). Iron corrosion staining can be seen to the stonework below, and the surface of the stone is quite friable, suggesting water overflows regularly.

**Figure 14:** Guttering to west side of south porch, showing deformation and slight split.

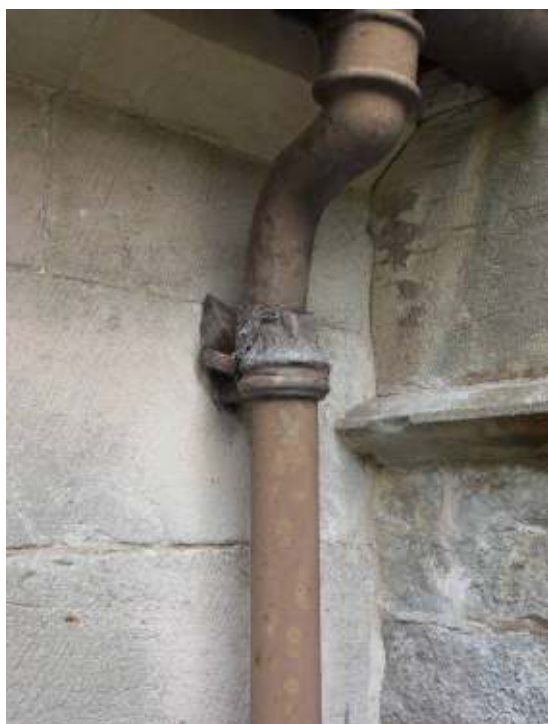
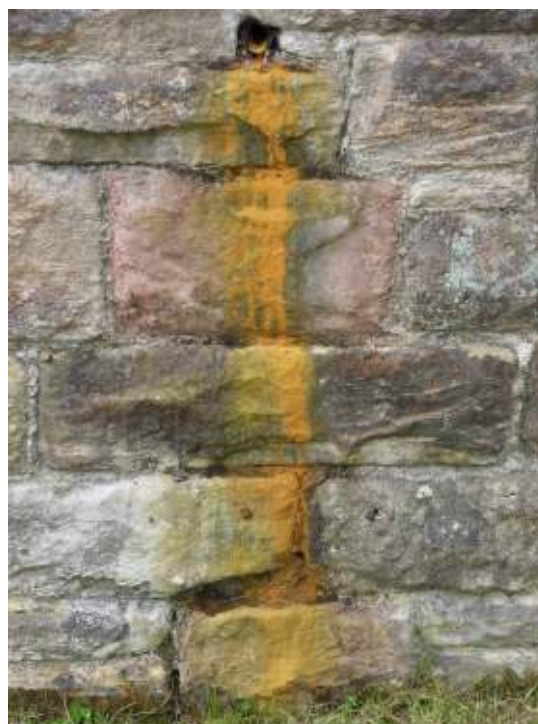
**Figures 15 and 16:** Detail of damaged downpipe to south porch (left) and overflow pipe in the north wall of the vestry, with iron corrosion staining to wall beneath (right).

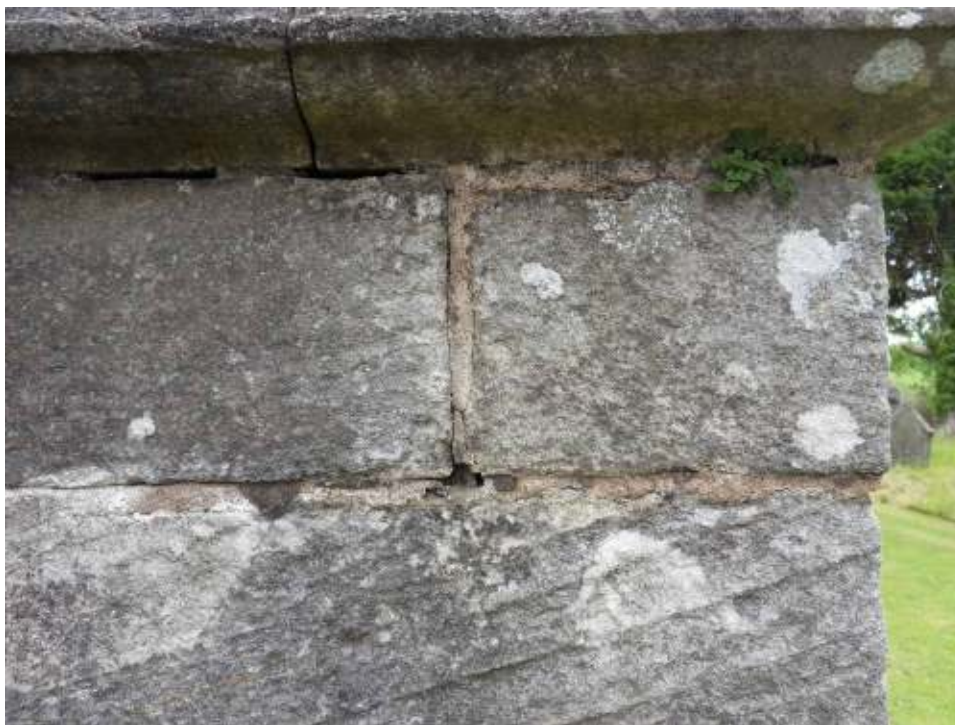
**Figure 17:** Detail of area of failing pointing on the south porch, with small plant growing out of void.

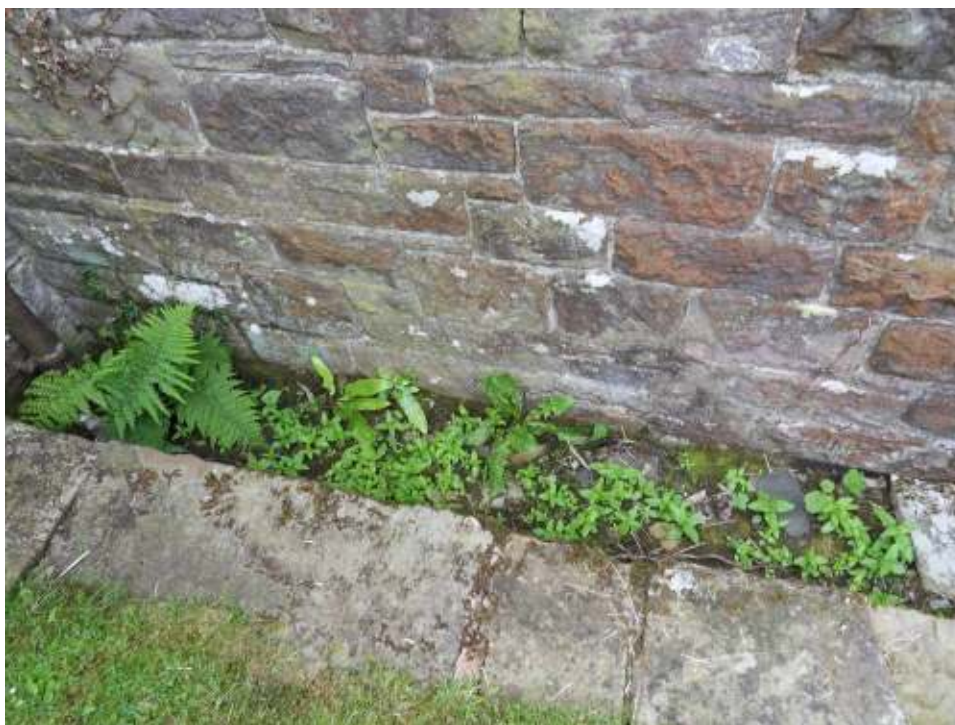
**Figure 18:** Extensive biological growth found in the north gully.

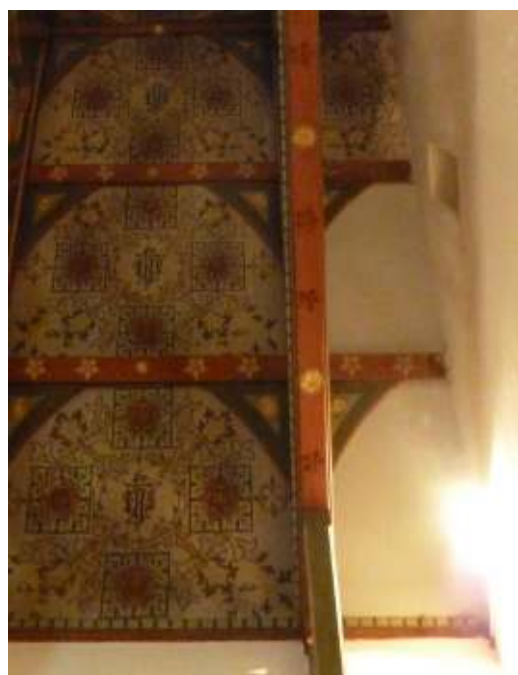
Two of the western-most part panels on the south side of the nave ceiling have been replaced with new plaster, and have yet to be repainted (figure 20). These were replaced following a leak from a blocked gully, and all of the part panels in this western-most bay are suffering from water damage. The 4 part panels that have not had their plaster replaced, all show signs of water ingress; there is a whitish bloom and salts evident, particularly to the lower panel on the north side (see figure 21).

**Figure 20:** Detail of replaced plaster to two westernmost panels on south side of the ceiling. Note the water damage to the right side of the panel above.

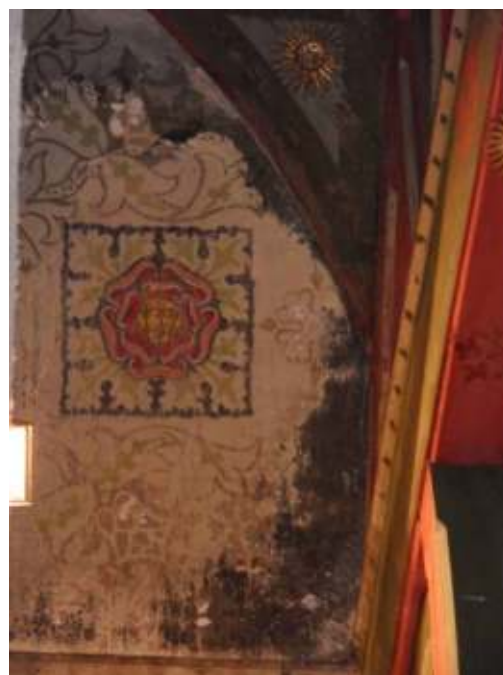
**Figure 21:** Detail of water damage and staining (possibly mould) to lower westernmost panel on north side of the ceiling. Access to this panel was not available on the day of the inspection.

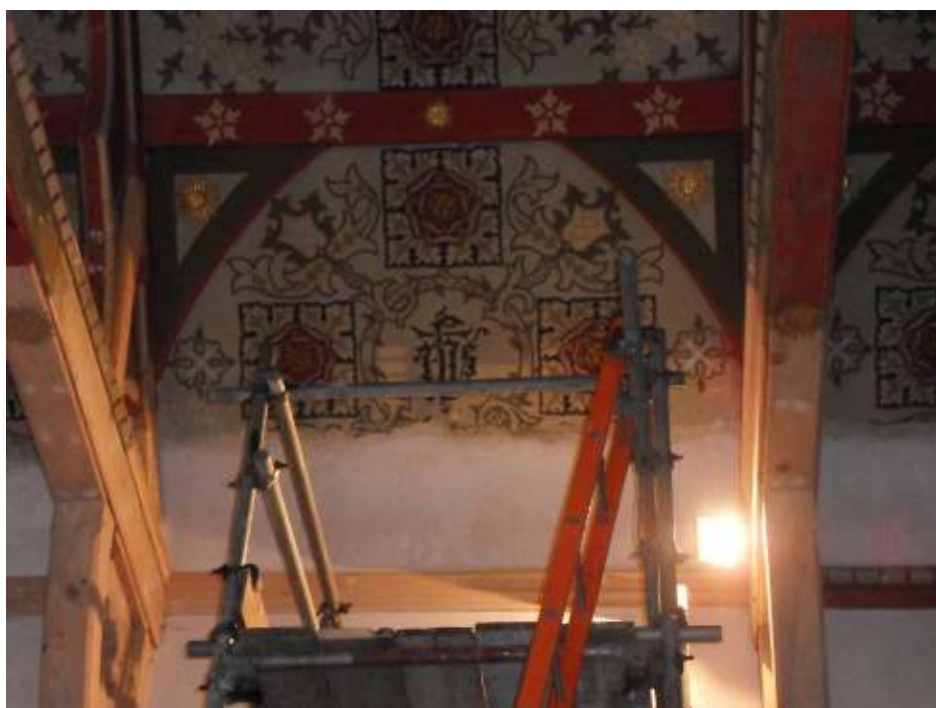
At the far south east corner of the nave, the lower third of two full and one part ceiling panel have had the plaster replaced, and have yet to be repainted (figure 22). This damage was again as a result of water ingress from the blocked gully. The replacement plaster is clearly lime based, but the surface is quite rough and the junction between the earlier and replacement plasters is stepped and uneven (see figures 23 and 24). A large section of wall plaster has also been replaced in this area. The ends of the two easternmost beams, trusses and spandrels have been spliced in to the existing, to replace rotten timber.

**Figure 22:** Overview of replacement plaster and timber to the central of the three repaired panels.

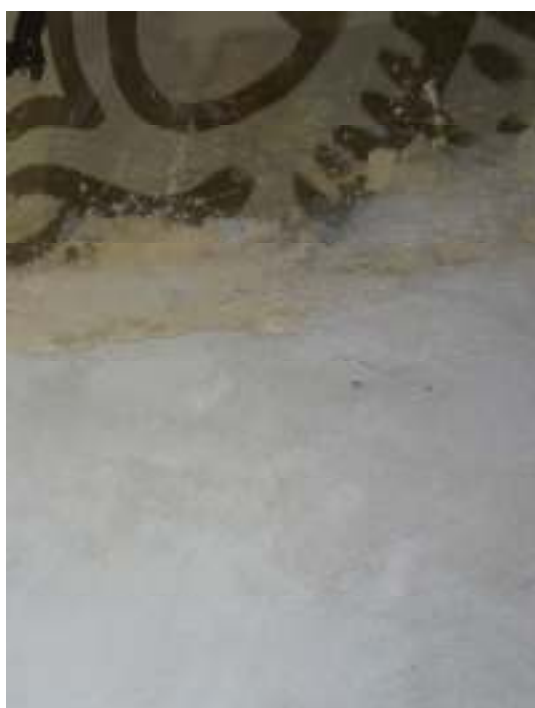
**Figure 23:** Detail of junction between replacement plaster and original decoration. Note the uneven finish and step in plaster edge.

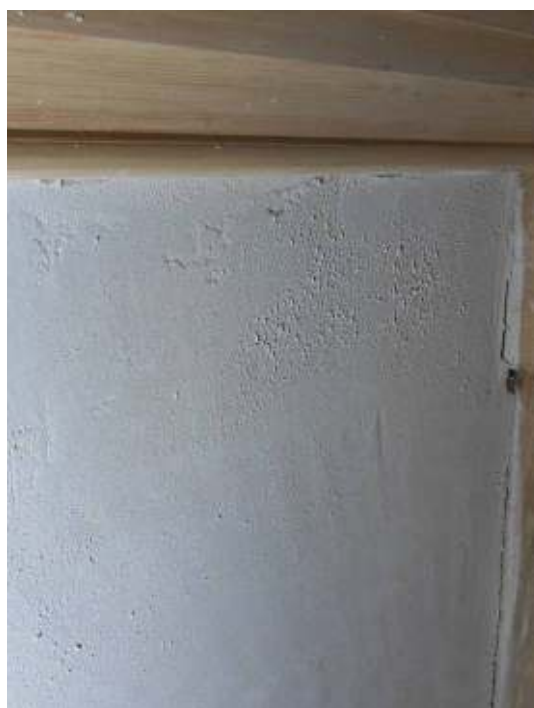
**Figure 24:** Detail of replacement plaster surface, showing uneven finish.

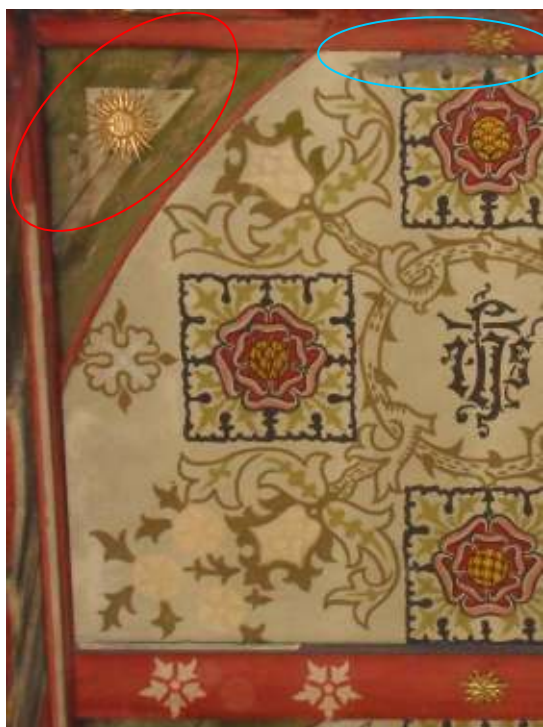
The painted surfaces are heavily soiled; there are cobwebs running along the panels and beams and numerous water stains are evident, particularly on the tie beams and trusses (see figures 25 and 26). There are also splashes of plaster on the paint surface of the panels and timber beams surrounding the replaced panels (figure 28). Areas of original paint have been lost by wiping away residues during repair, particularly evident on the timber beams (see figure 27).

**Figure 25:** Detail of ceiling panel to north side of the ceiling showing cobwebs (blue circle) and evidence of water ingress, including staining and paint loss (red circle).

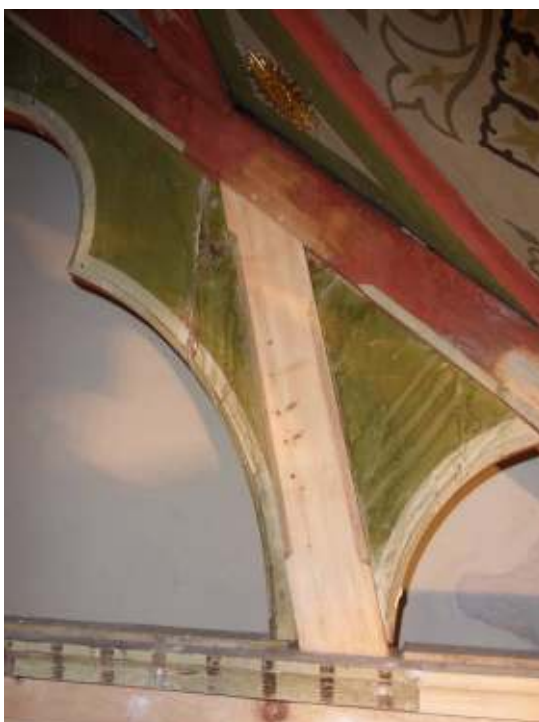
**Figure 26:** Detail of replacement timber and water run-off marks and lost paint to original decoration.

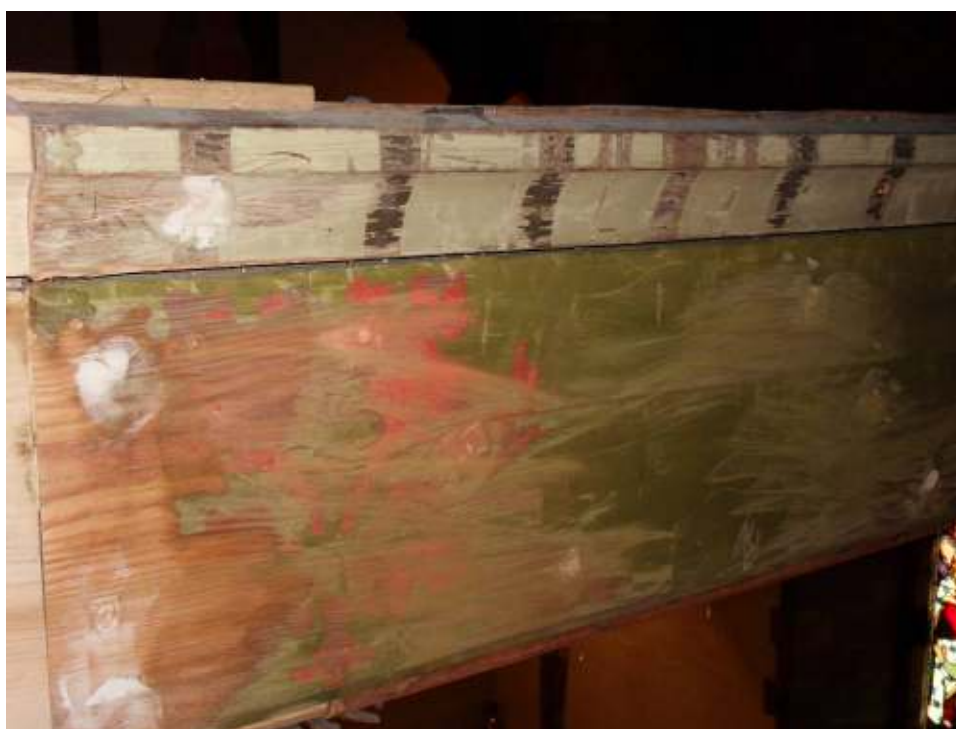
**Figure 27:** Detail of area of damage to original decoration following the fixing of replacement timber.

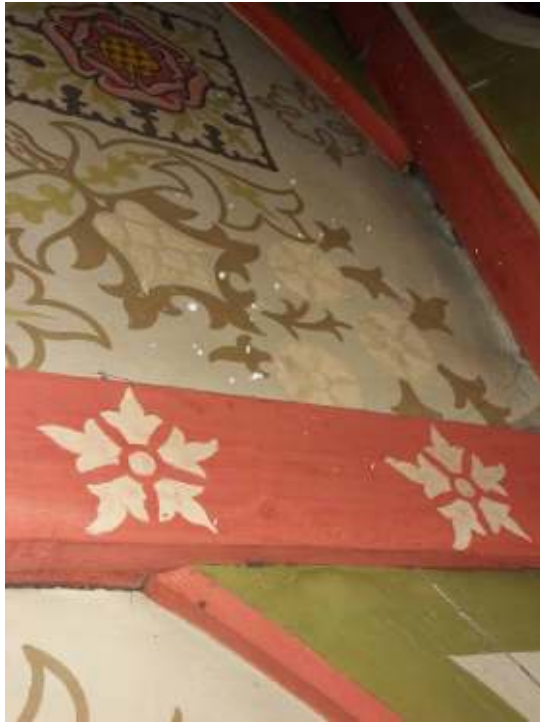
**Figure 28:** Detail of ceiling panel to south side showing white splashes of plaster, presumably from the recent repairs.

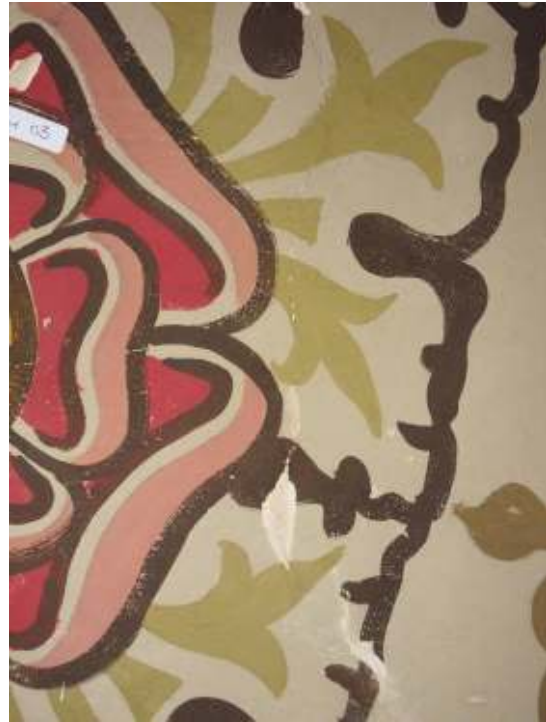
Numerous areas of flaking paint are evident, particularly on the timber spandrel, where the paint surface is heavily crazed and along the edges of fractures (figure 29). Generally the flaking is evident along the grain of the wood, which suggests that this

**Figure 29:** Detail of paint losses along the edge of a fine fracture.

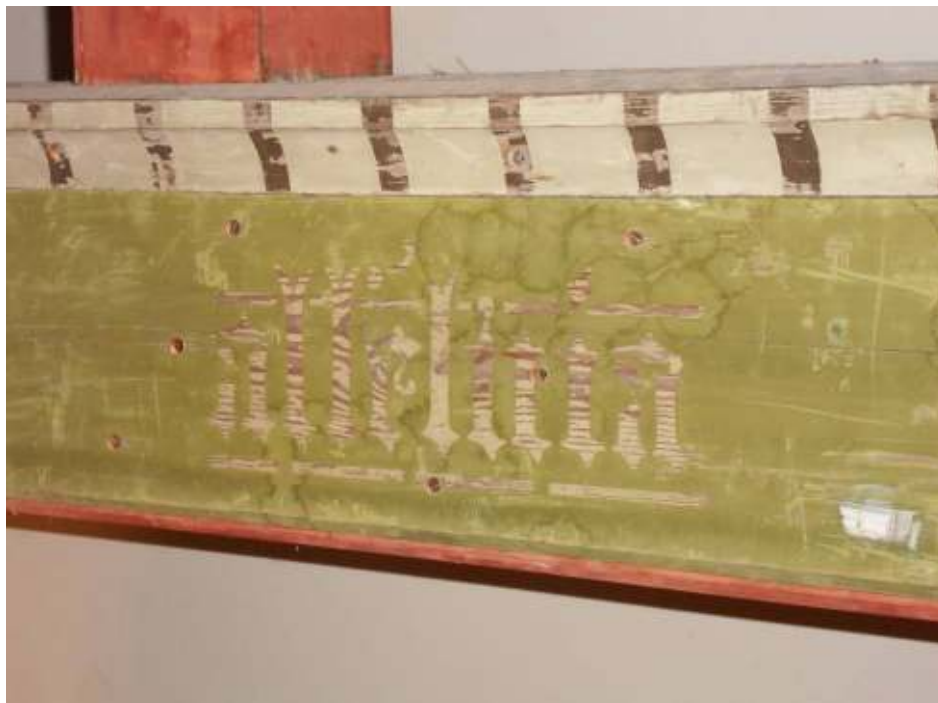
**Figure 30:** Detail of timber beam showing unfilled fixing holes and paint losses, particularly evident in the text following the grain of the wood.

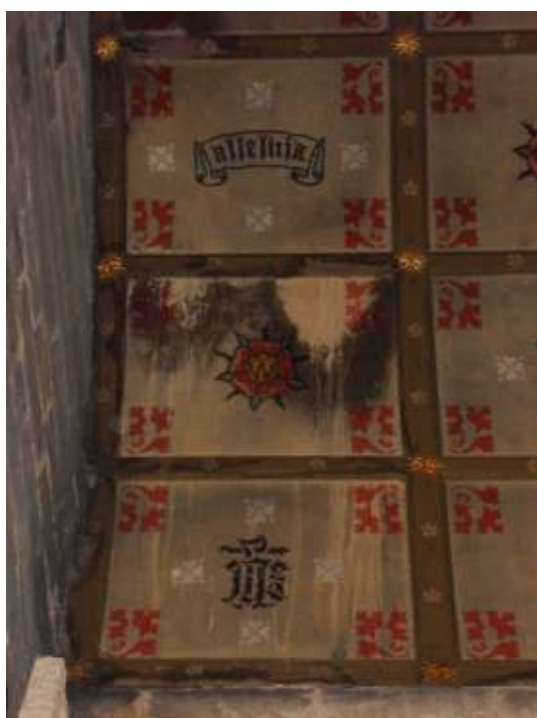
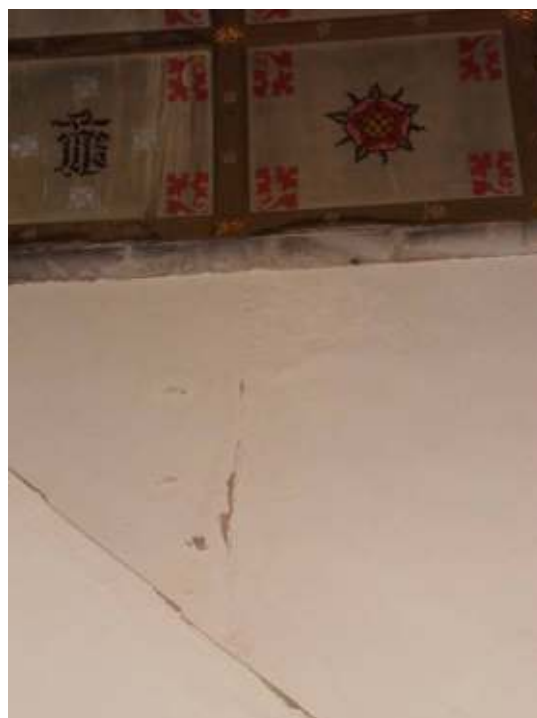
The lower four ceiling panels in the far north east corner of the south aisle have been replaced, following extensive damage from water ingressing from the blocked gully, and new timber frames spliced in. Several panels towards the west end of the ceiling, and the wall beneath, also show signs of previous water ingress, including staining, disrupted plaster surface and water run off marks (see figures 32-34).

**Figures 32 and 33:** Detail of water damage to north westernmost panels, showing staining (possibly black mould), water run-off marks and disrupted wall plaster and paint beneath (right).

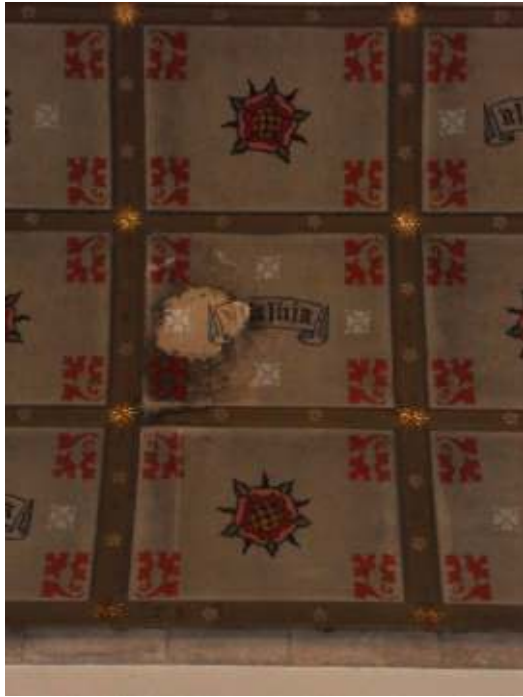
**Figure 34:** Detail of staining and water run-off marks as a result of historic water ingress.

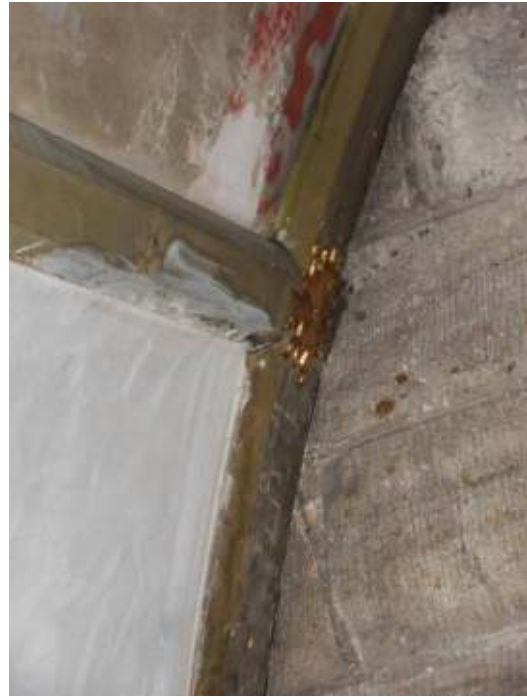
**Figure 35:** Detail of area of replacement plaster, showing staining to original decoration of surrounding timber frame.

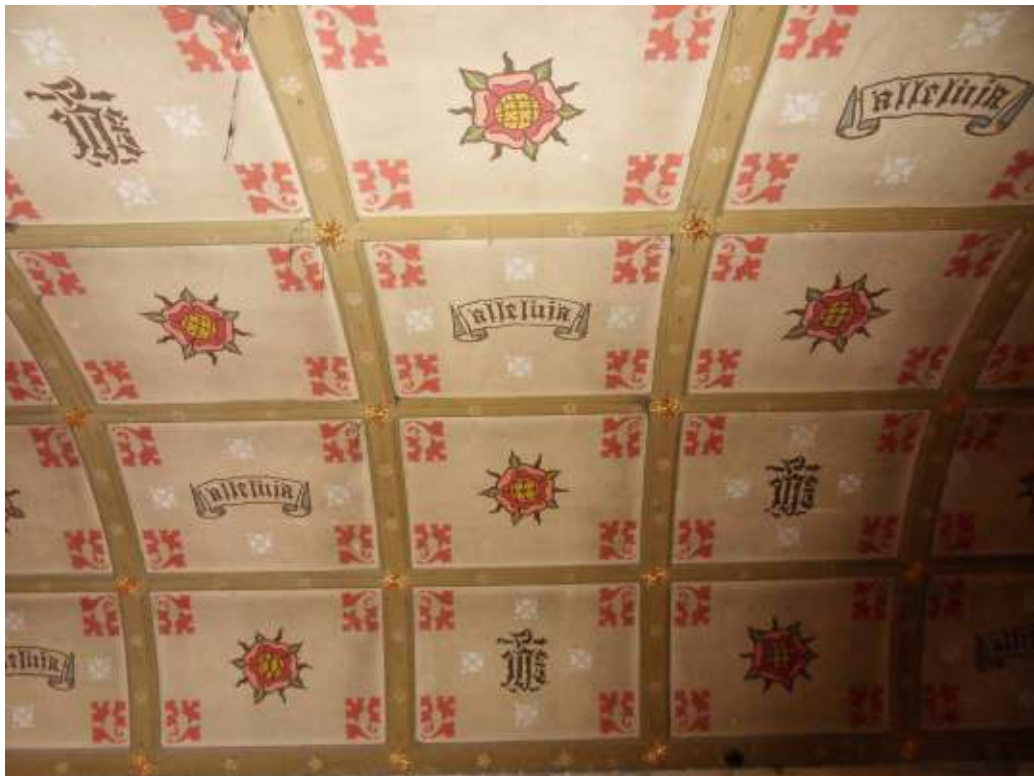
There is a large build up of surface dirt, dust and cobwebs (see figures 36 and 39). The timber frames surrounding the replacement panels have plaster residue on them and some of the original paint has been removed, seemingly when an attempt has been made to remove the excess mortar (figures 35 and 37). There appear to be water run off marks coming down from the beam above one replacement panel, possibly from washing off excess plaster from the beam. There are areas of minor paint loss along the edges of some fractures (see figure 38) and some recent impact damage in the form of scratches (figure 37).

**Figure 36:** Overview of south east side of ceiling showing surface dirt and cobwebs.

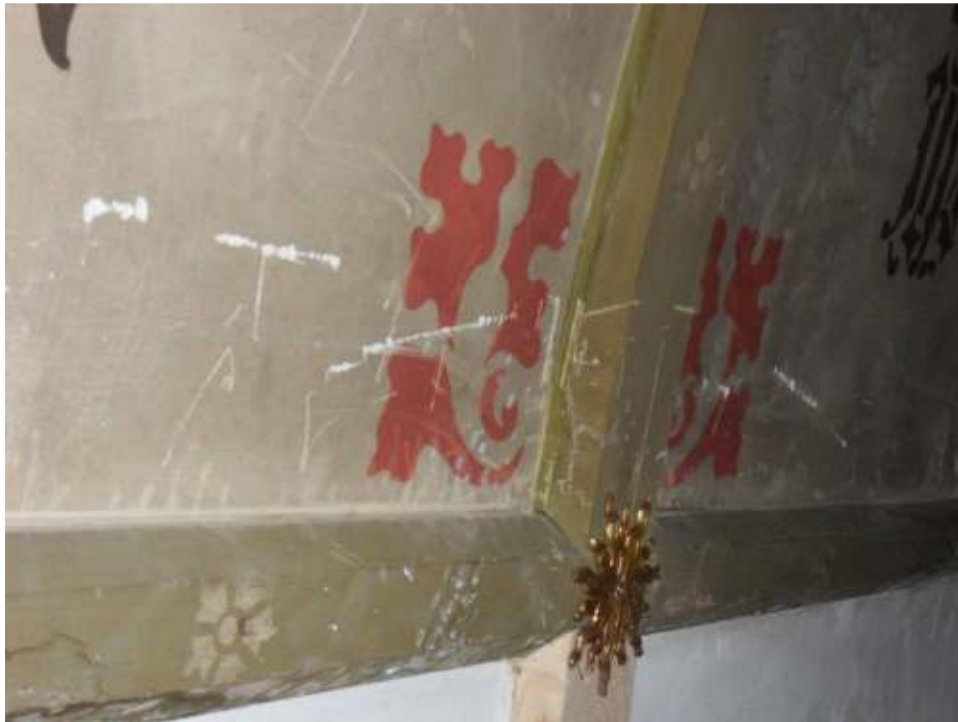
**Figure 37:** Detail of areas of impact damage – scratches and paint loss; these appear to be recent as there are no dirt deposits on the exposed plaster. Water staining and plaster marks can also be seen on the lower timber frame.

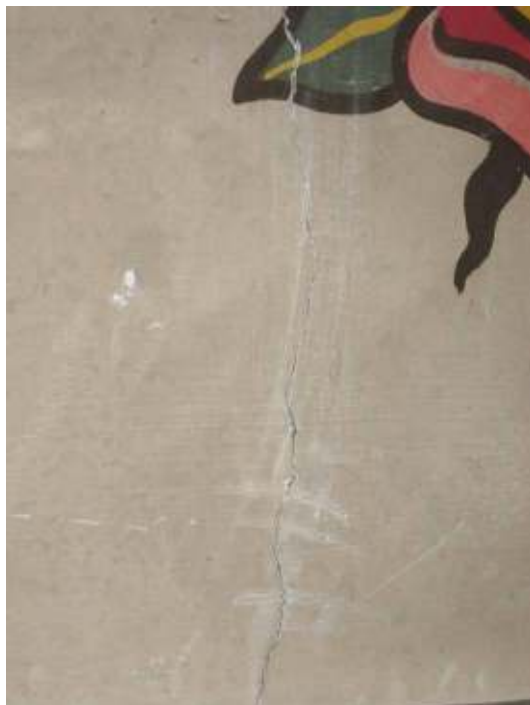
On close inspection, some fine fractures in the plaster panels were noted, although these can't be seen from ground level and they appear to be stable, with no movement detected in the area examined (figure 38). As it was not possible to closely assess each panel from the access tower, it is impossible to comment on the structural stability of most areas of the ceiling, although no significant fractures or bulging in the plaster were evident. There are some holes in the replacement timber frames that have not been filled.

**Figure 38:** Detail of fine fracture in surface of panel, with minor areas of flaking paint along its edge.

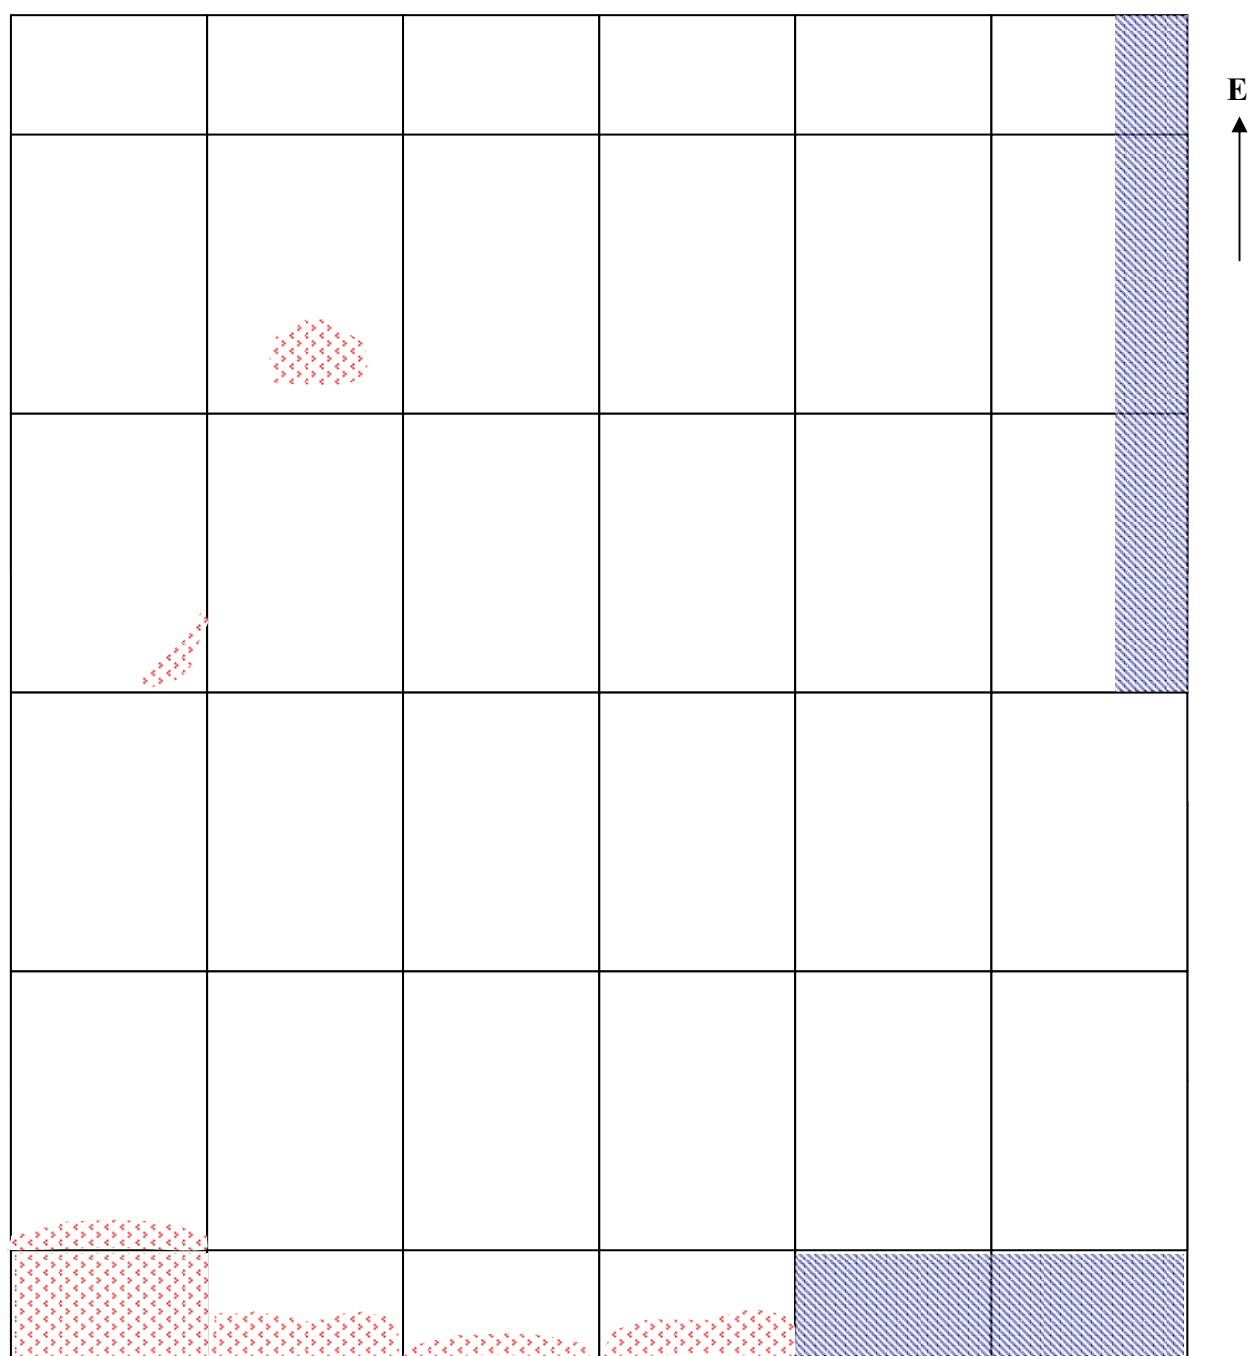
## Appendix 2 – Nave Ceiling Plan

Reflected view plan of the nave ceiling showing areas of replaced plaster and areas exhibiting signs of water ingress (staining, water run off marks).

Areas exhibiting signs of water ingress; staining, water run off marks etc.

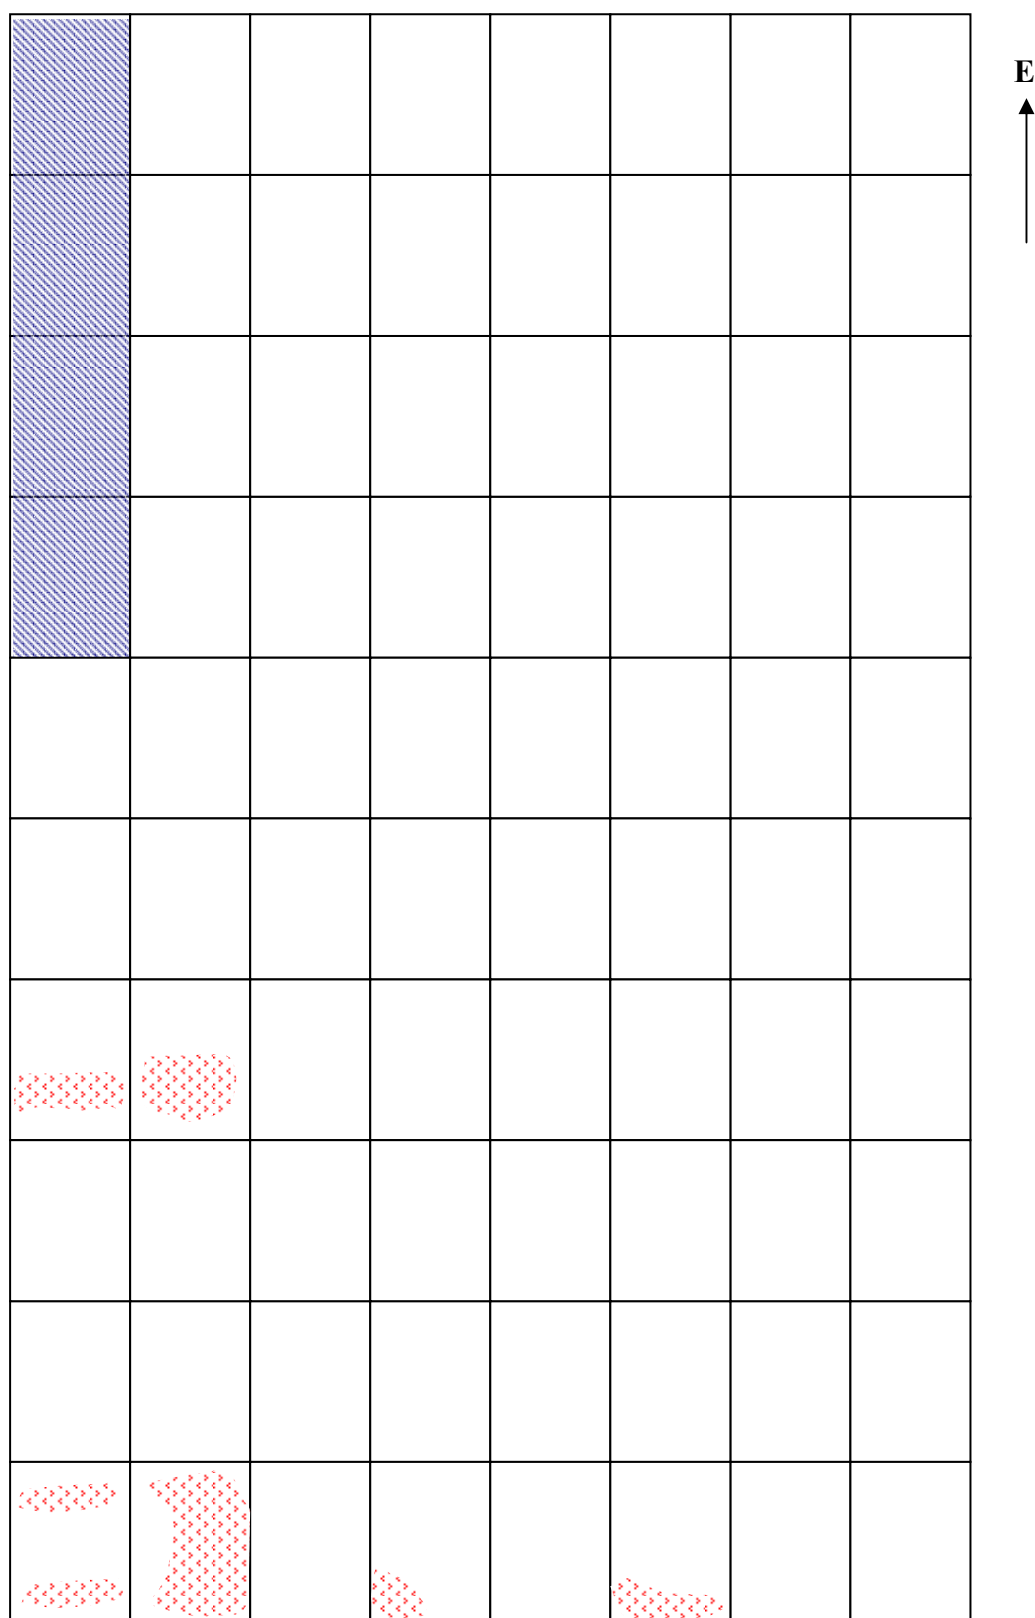
### Appendix 3 – South Aisle Ceiling Plan

Reflected view plan of the south aisle ceiling showing areas of replaced plaster and areas exhibiting signs of water ingress (staining, water run off marks).
