**Treatment Report for the Nave and South Aisle Ceilings,  
St Bridget's Church, Brigham, Cumbria**

**Diocese of Carlisle**

**November 2013**

**St Bridget's Church  
BRIGHAM**

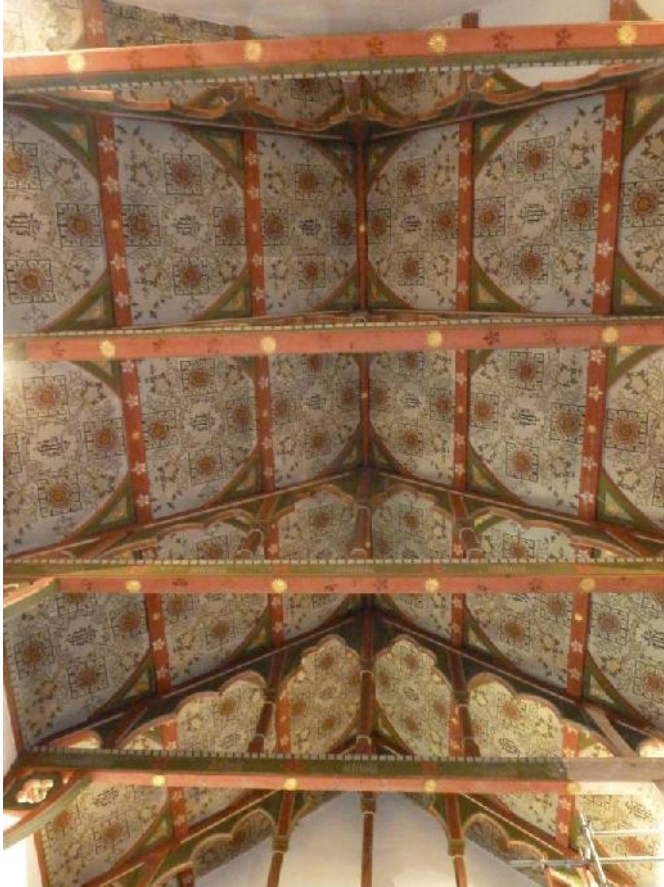
**Figure 5:** Overview of nave ceiling before treatment looking east.

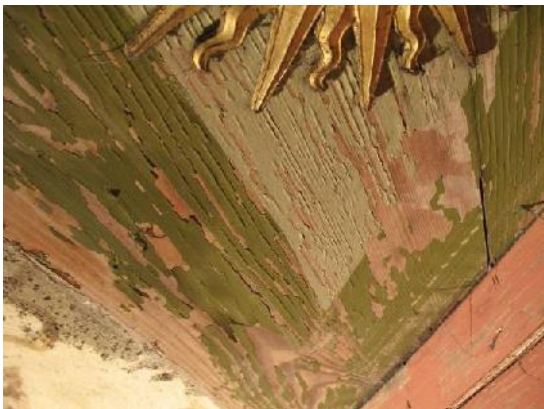
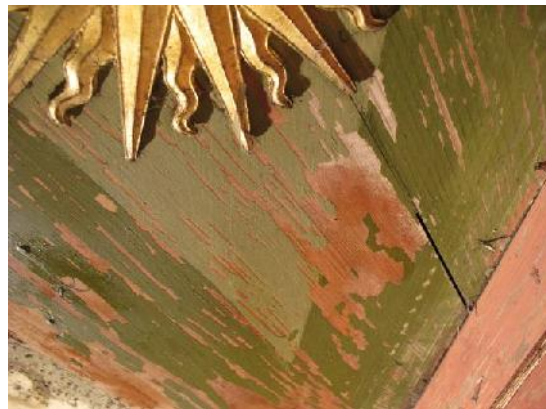
**Figures 6 and 7.** Details of an area of flaking paint before (left) and after (right) the spray application of consolidant.

The spray application of 7-10% solution of Paraloid B72 was found to be particularly effective at consolidating the failing paint on the moisture and salt affected panels and timbers. Paraloid B72 is an ethyl methacrylate/methyl acrylate co-polymer, that (dissolved in xylene or acetone in varying concentrations) has been widely used in conservation over the last 30 years as a consolidant, retouching medium, and as an isolating or final varnish. It remains chemically stable overtime and is not affected by light. Although a slight darkening of the paint surface was noted following spray application, this was considered to be at an acceptable level due to its stability.

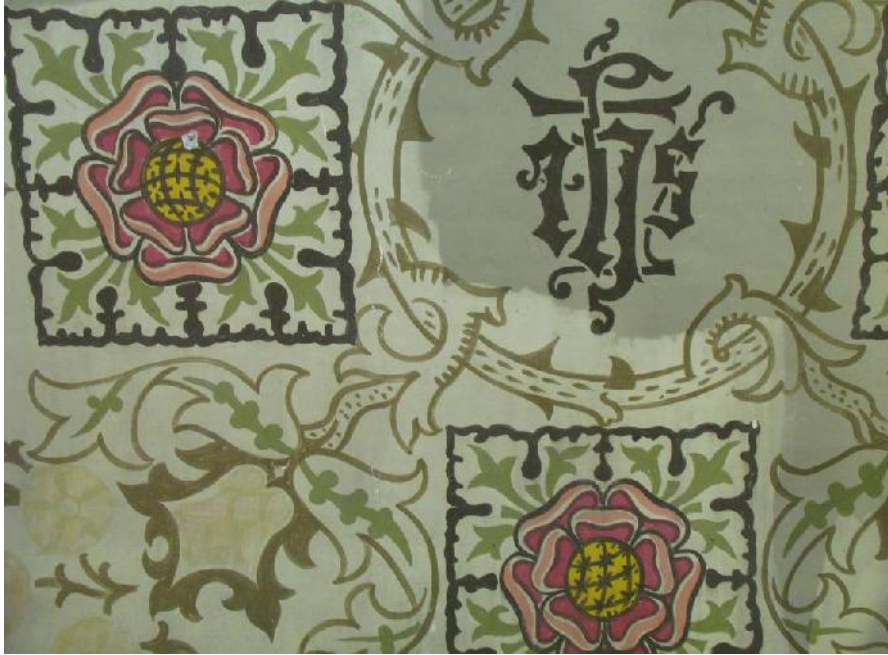
It was noted at the start of the works that the white flowers in the nave ceiling panels had at some point been crudely overpainted in a buff/ochre colour oil paint, possibly in an attempt to make them less noticeable, see figure 8. Following discussions with the client, it was decided that when the decoration to the missing and damaged westernmost panels was recreated, these flowers would remain white in order to demonstrate how the panels would have looked originally, see figure 11.

**Figure 8.** Detail of ceiling panel during cleaning with a Wishab sponge.

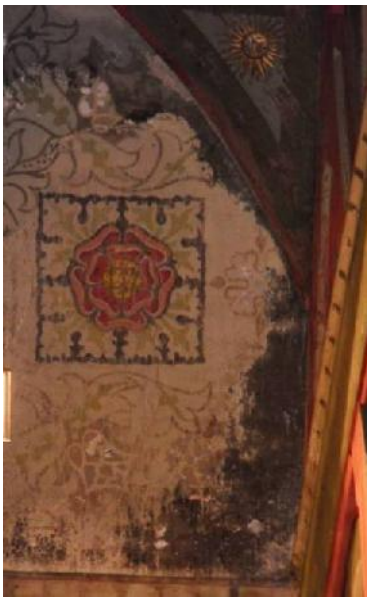
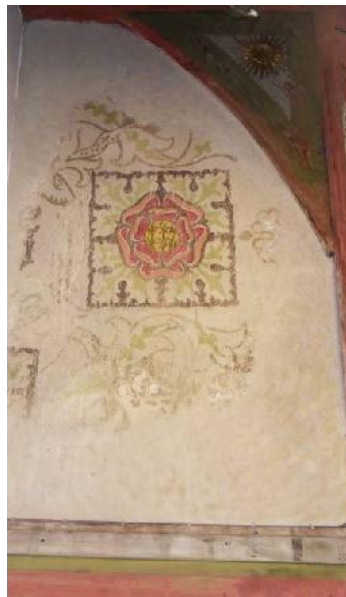
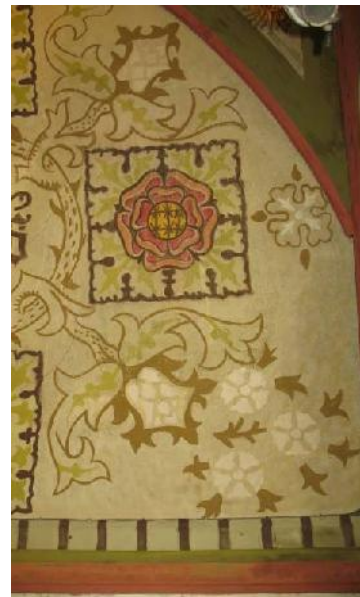
**Figures 9-11:** Lower westernmost panel on north side of the ceiling before, during and after treatment.

The extensive staining and salt damage to panels in both the south aisle and the nave necessitated extensive re-painting in distemper paint, see figures 9-11 and 28-31. These areas are plotted onto the ceiling plans in Appendix 2. Where there were large areas of loss to isolated stencilled designs, such as the red flowers on the undersides of the nave beams, these were re-stencilled, see figures 12 and 13.

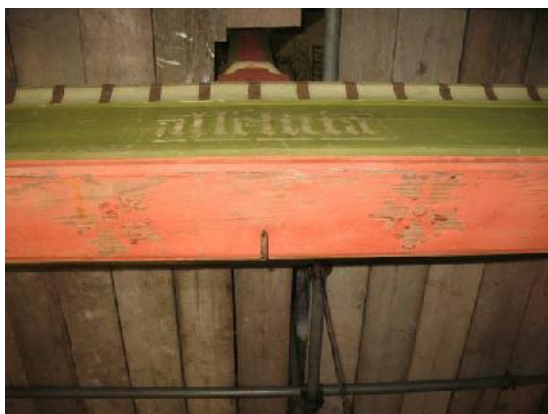
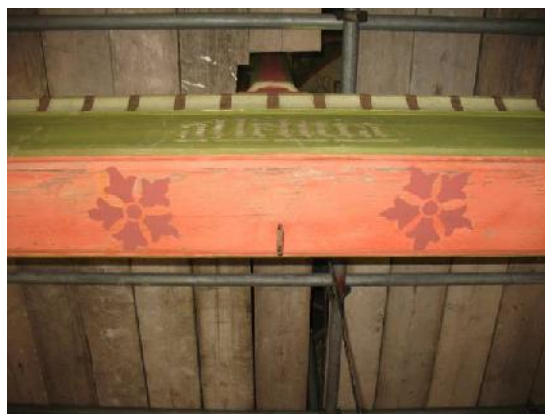
**Figures 12 and 13.** Details of the underside of a beam before and after recreation of missing stencilled design.

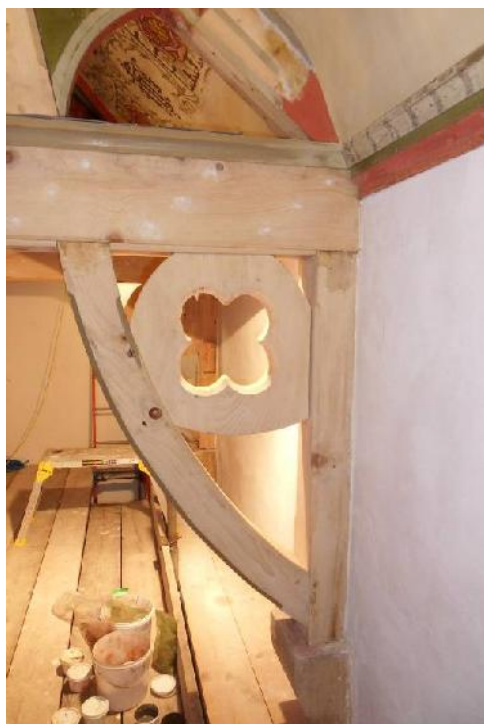
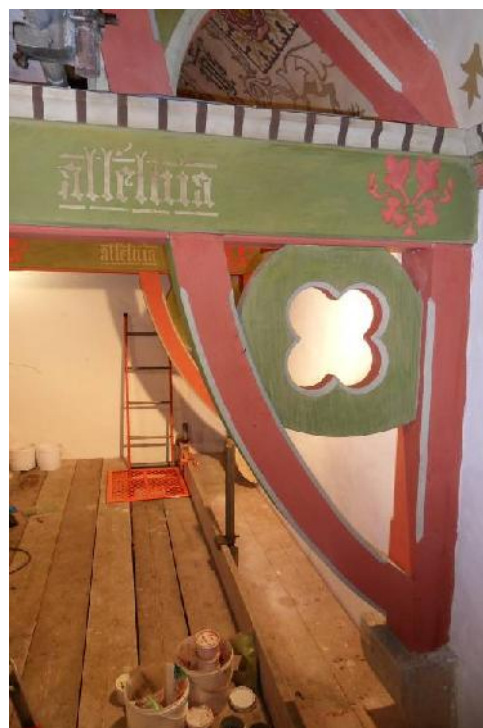
**Figures 14 and 15.** Details of replacement beam and truss before and after recreation of decoration.

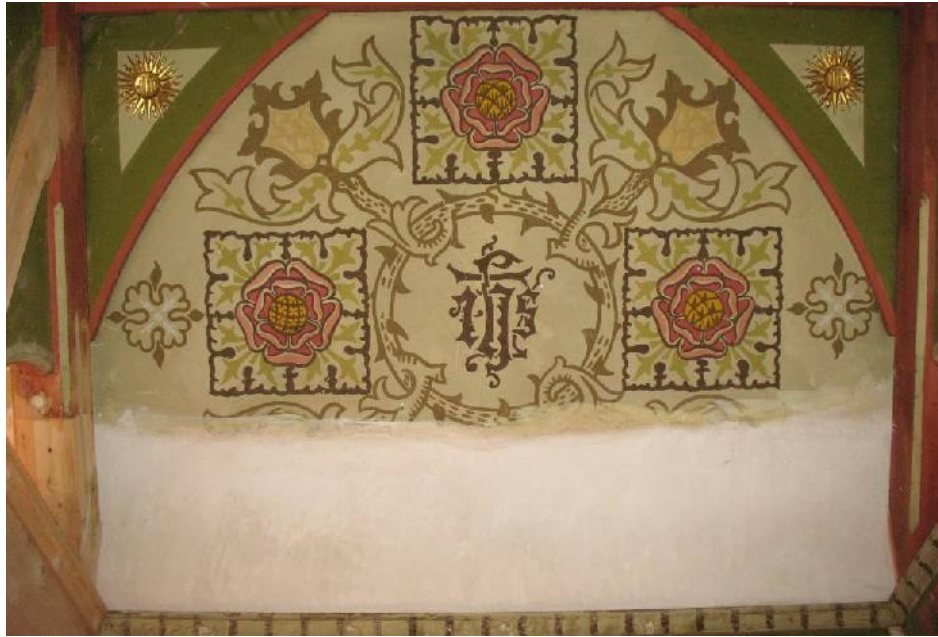
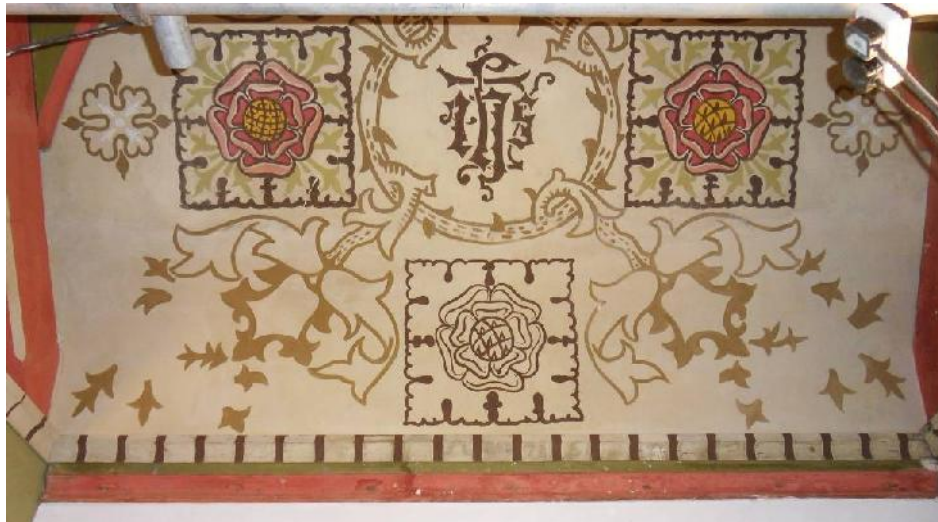
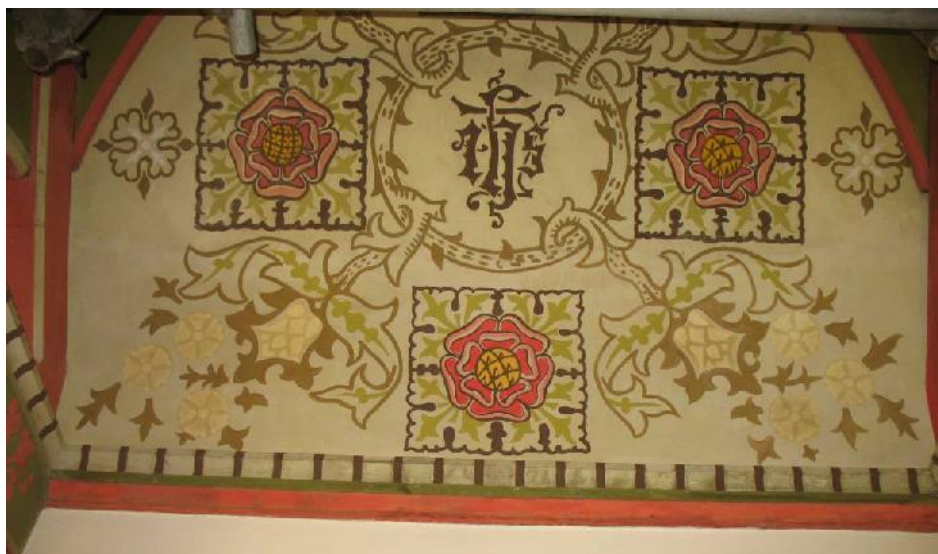
**Figures 16-18.** Details of repaired panel before, during and after recreation of decoration.

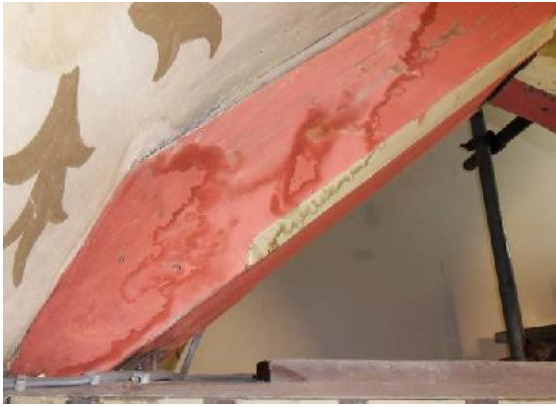
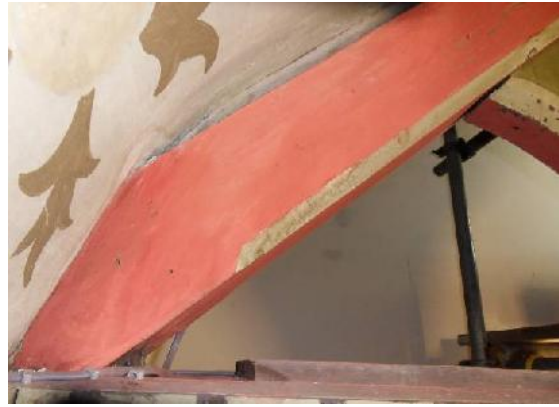
**Figures 19 and 20.** Details of area of tide marks/water staining before and after toning with dry pastels.

Very dark tide marks and staining to the beams in the nave were disguised by the use of dry pastel crayons in matching colours, see figures 19 and 20. In addition, integration of the localised areas of paint loss was then undertaken, without filling of lacunae, using distemper paint and/or watercolours.

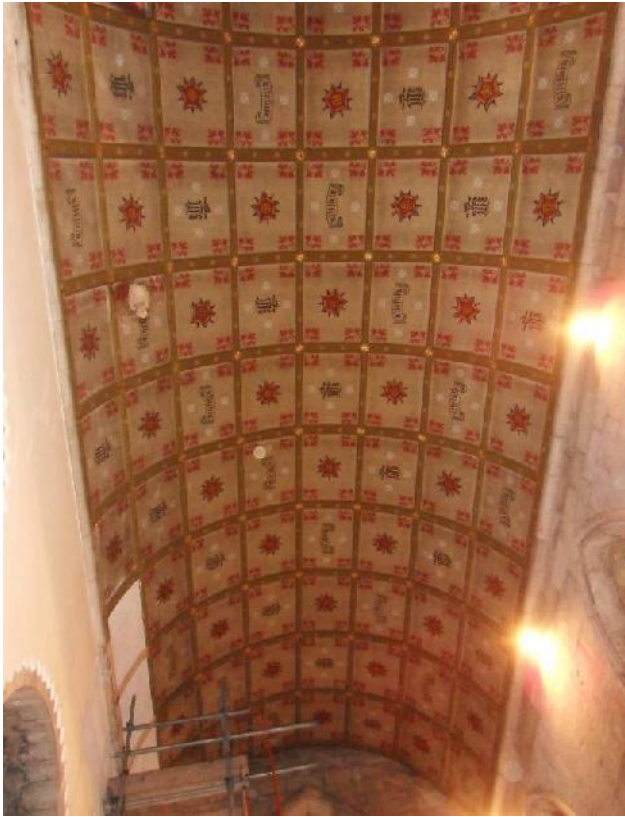
**Figure 22:** Overview of the south aisle ceiling during the condition assessment. Note the replaced plaster panels in the north east corner, with access scaffold beneath.

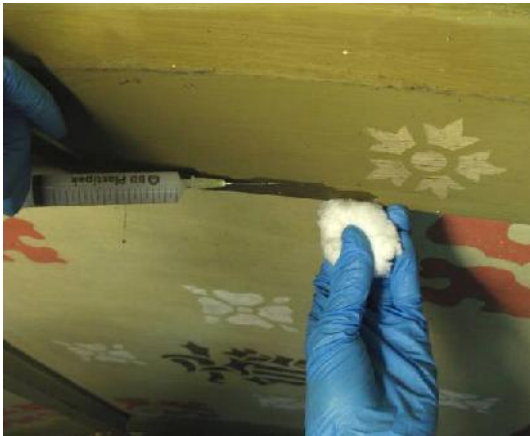
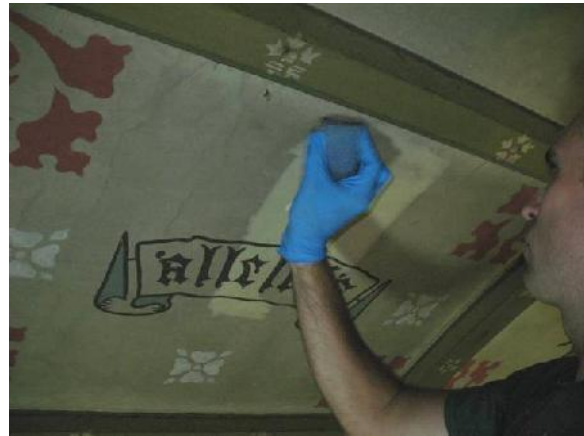
**Figures 23 and 24.** Detail of injection of consolidant behind loose paint flake (left), and dry cleaning the painted panels using Wishab sponge (right).

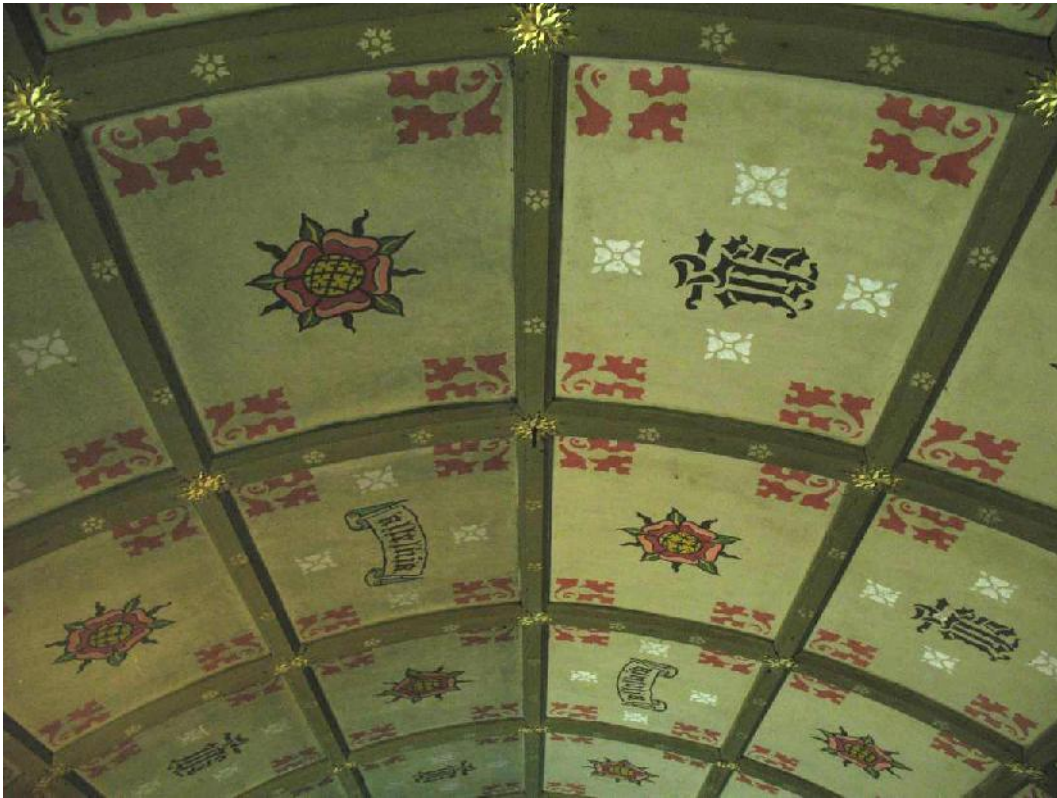
**Figure 25.** Section of the ceiling during cleaning – note the cleaned panels on the right hand side.

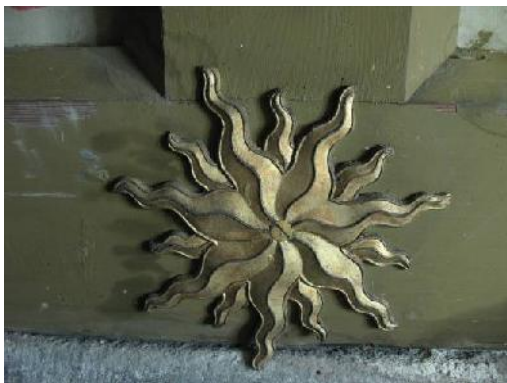
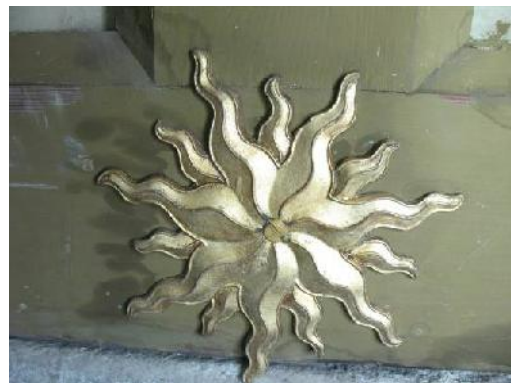
**Figures 26 and 27.** Details of gilded star before (left) and after (right) cleaning.

Further cleaning of the paint surfaces was undertaken to remove hygroscopic dirt deposits and to enable recreation of the lost areas of decoration in the correct colours. Given the extreme sensitivity of the paint films to water and solvents, only dry cleaning methods were used. Initial cleaning trials had suggested that Wishab sponges (AKA pad) provided the most effective clean without causing any damage to the paint films, see figures 8, 24 and 25. This was supplemented with some further cleaning with Artgum erasers to the lighter passages where required (natural gum, non-abrasive eraser with a deep cleaning powder additive). The gilded stars were surface cleaned using a weak solution of ammonium hydroxide pH 8.5, applied with cotton wool swabs, see figures 26 and 27.

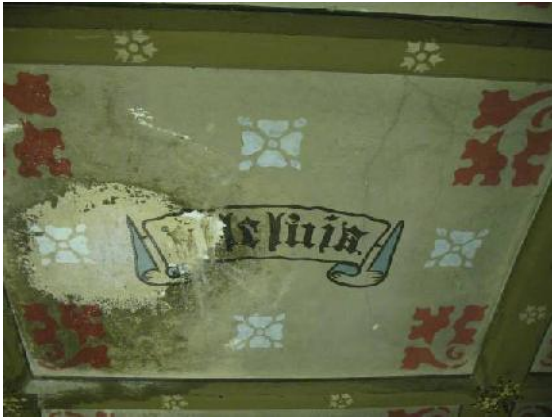
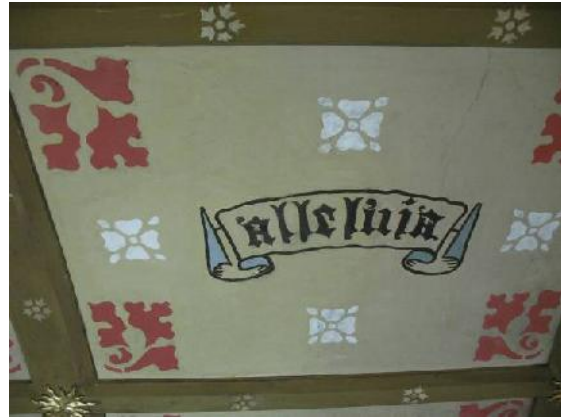
**Figures 28 and 29.** Details of water stained and salt damaged panel before (left) and after (right) treatment.

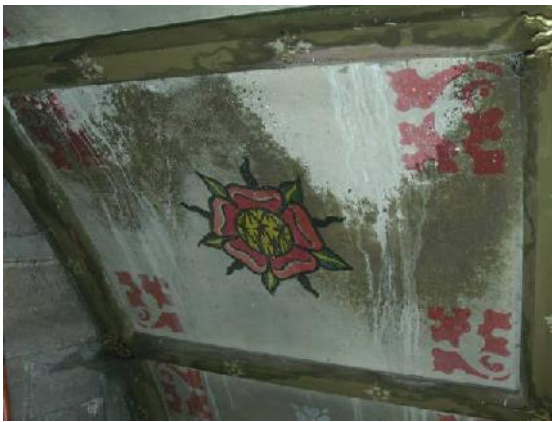
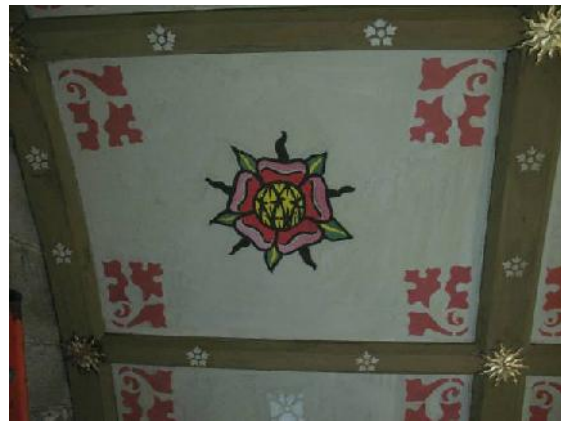
**Figures 30 and 31.** Details of water stained and salt damaged panel before (left) and after (right) treatment.

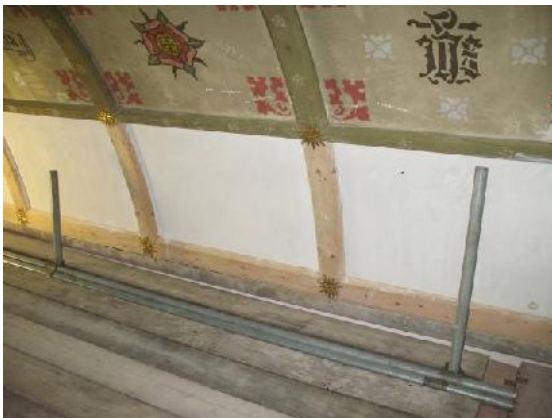
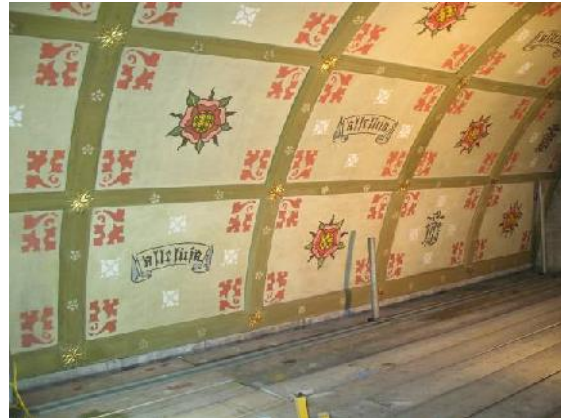
**Figures 32 and 33.** Details of replaced plaster panels in north east corner before and after recreation of stencilled decoration.

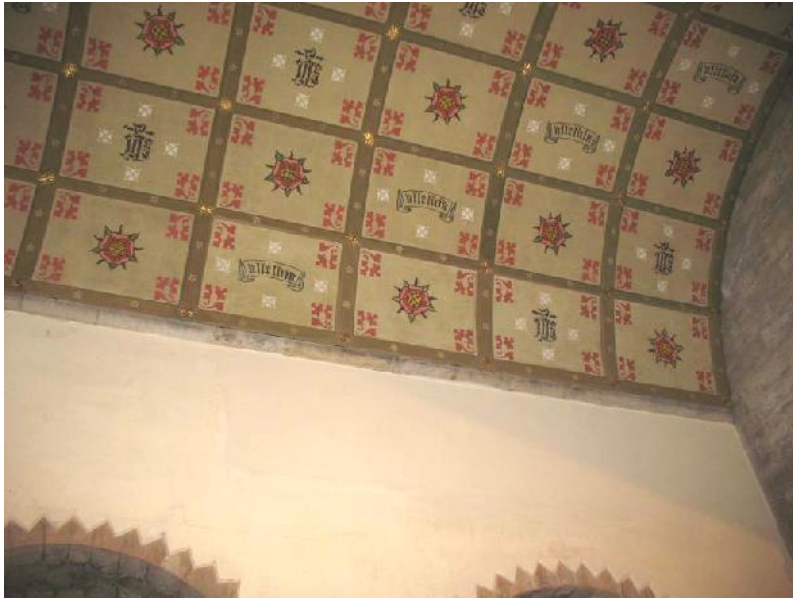
**Figure 34.** Overview of north east corner panels and colour matched distemper to upper wall following removal of scaffolding.

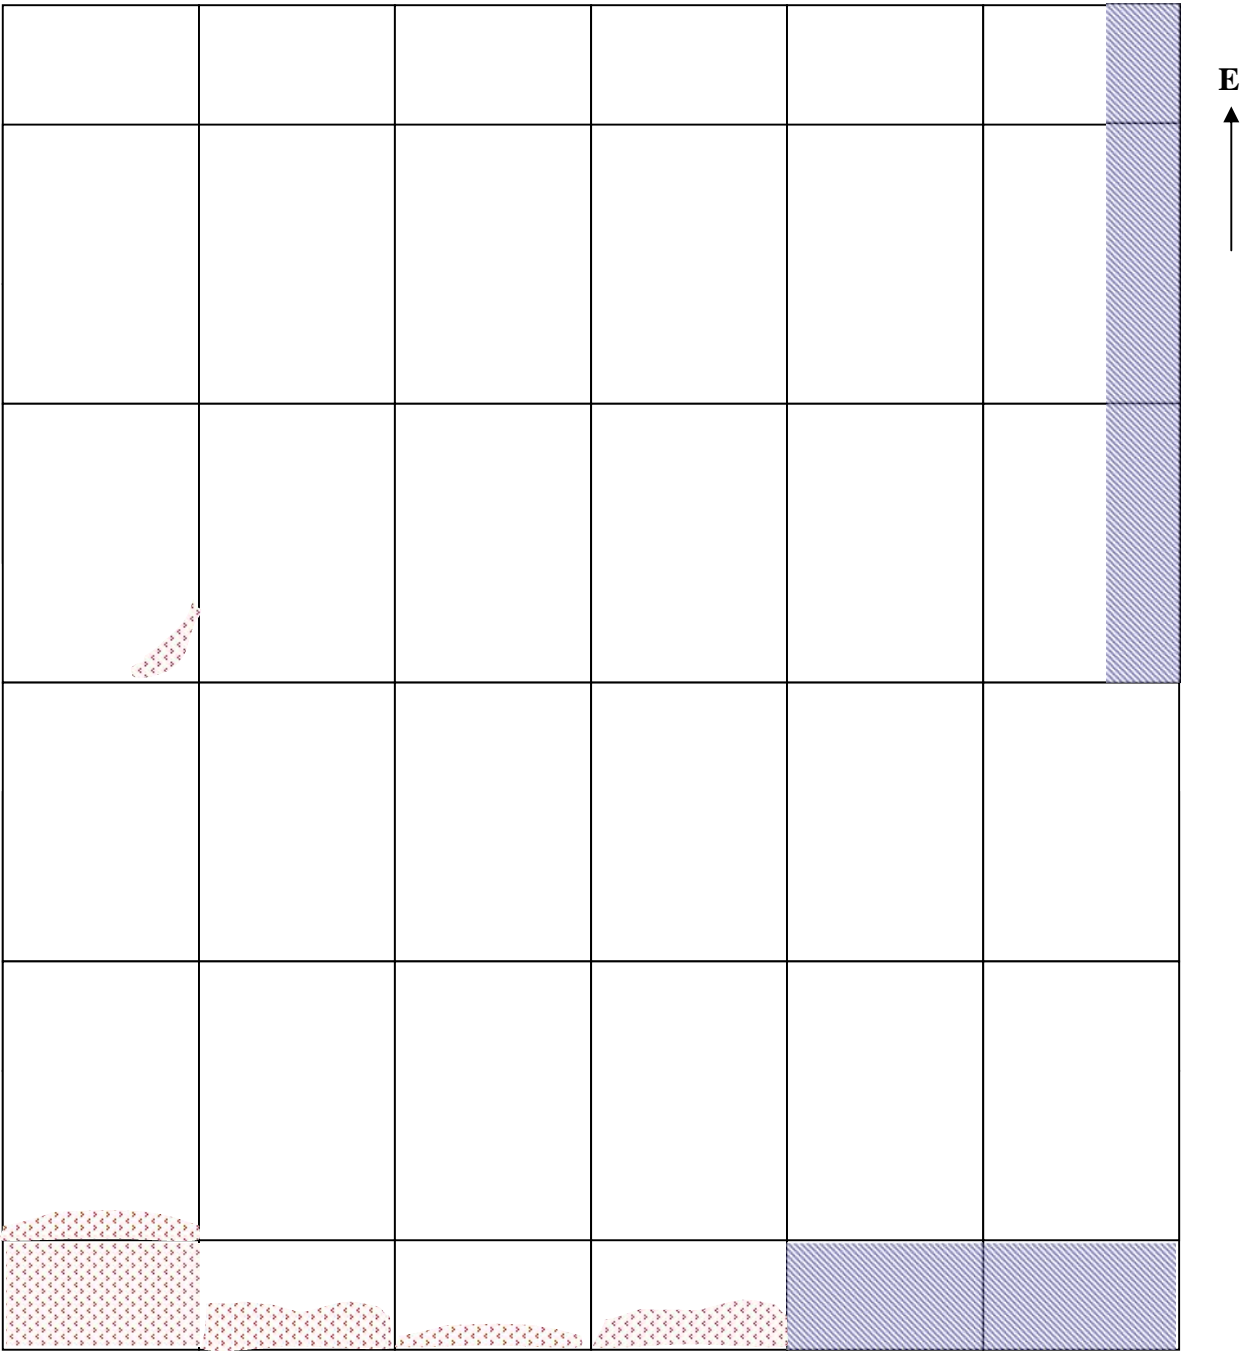
Reflected view plan of the **nave** ceiling showing recreated designs to areas of replaced plaster and areas requiring some re-painting due to salt pustules, staining and water run off marks.

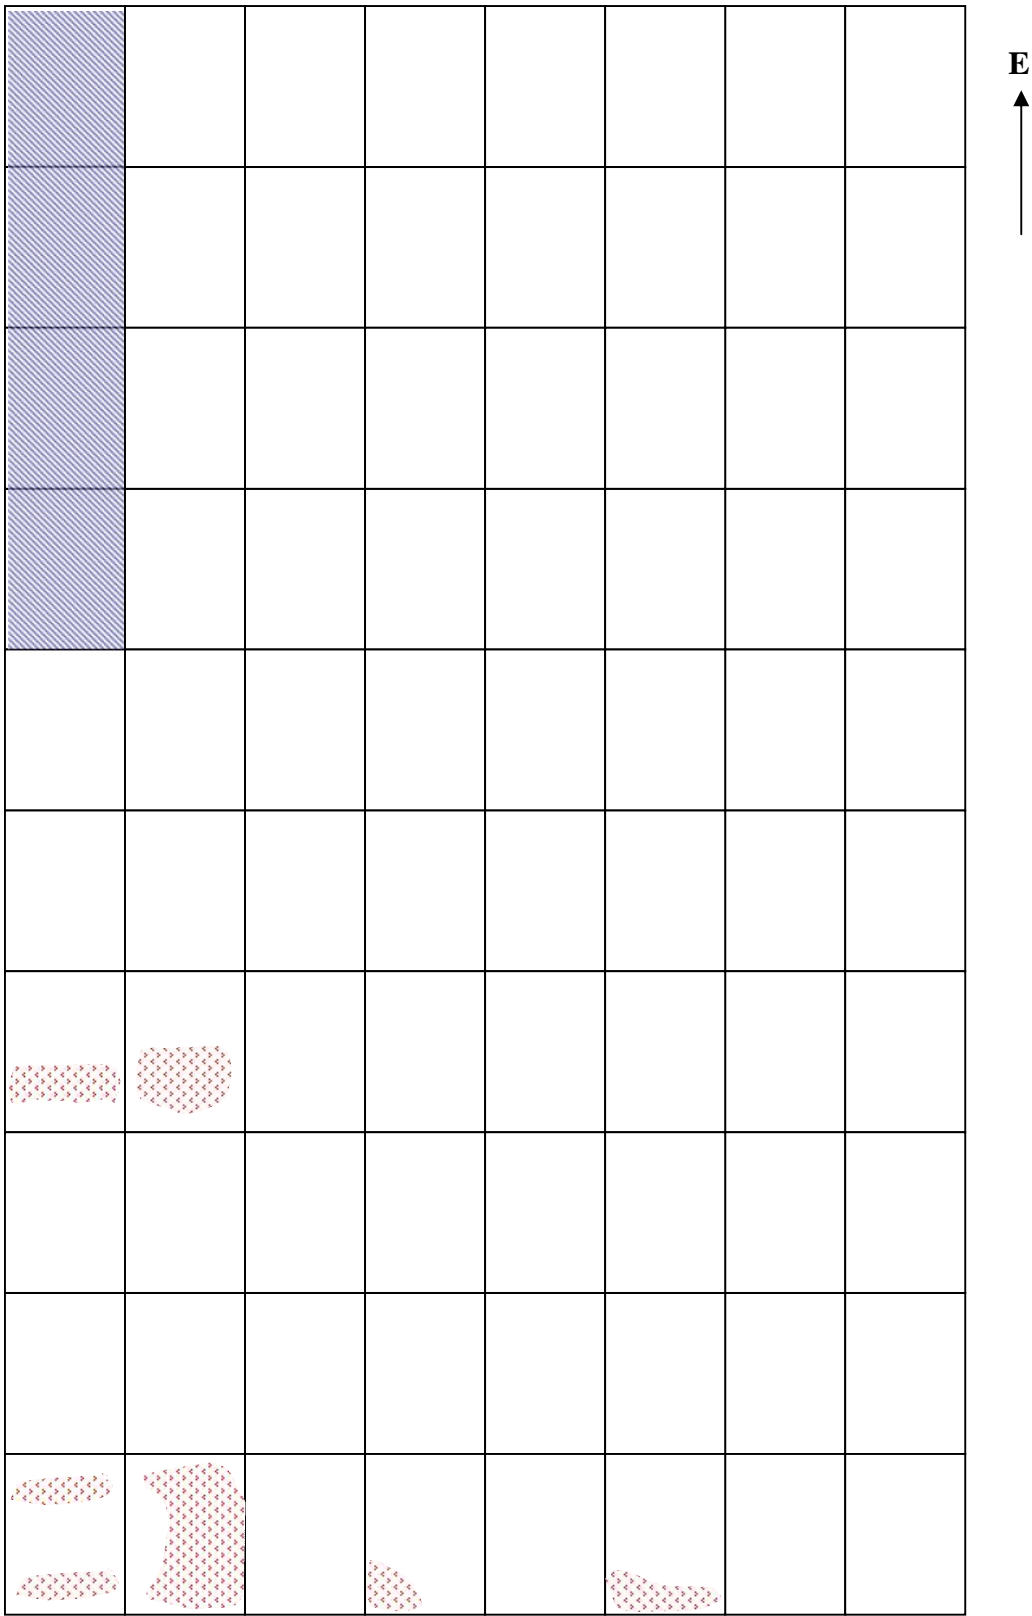
Reflected view plan of the **south aisle** ceiling showing recreated designs to areas of replaced plaster and areas requiring some re-painting due to salt pustules, staining and water run off marks.

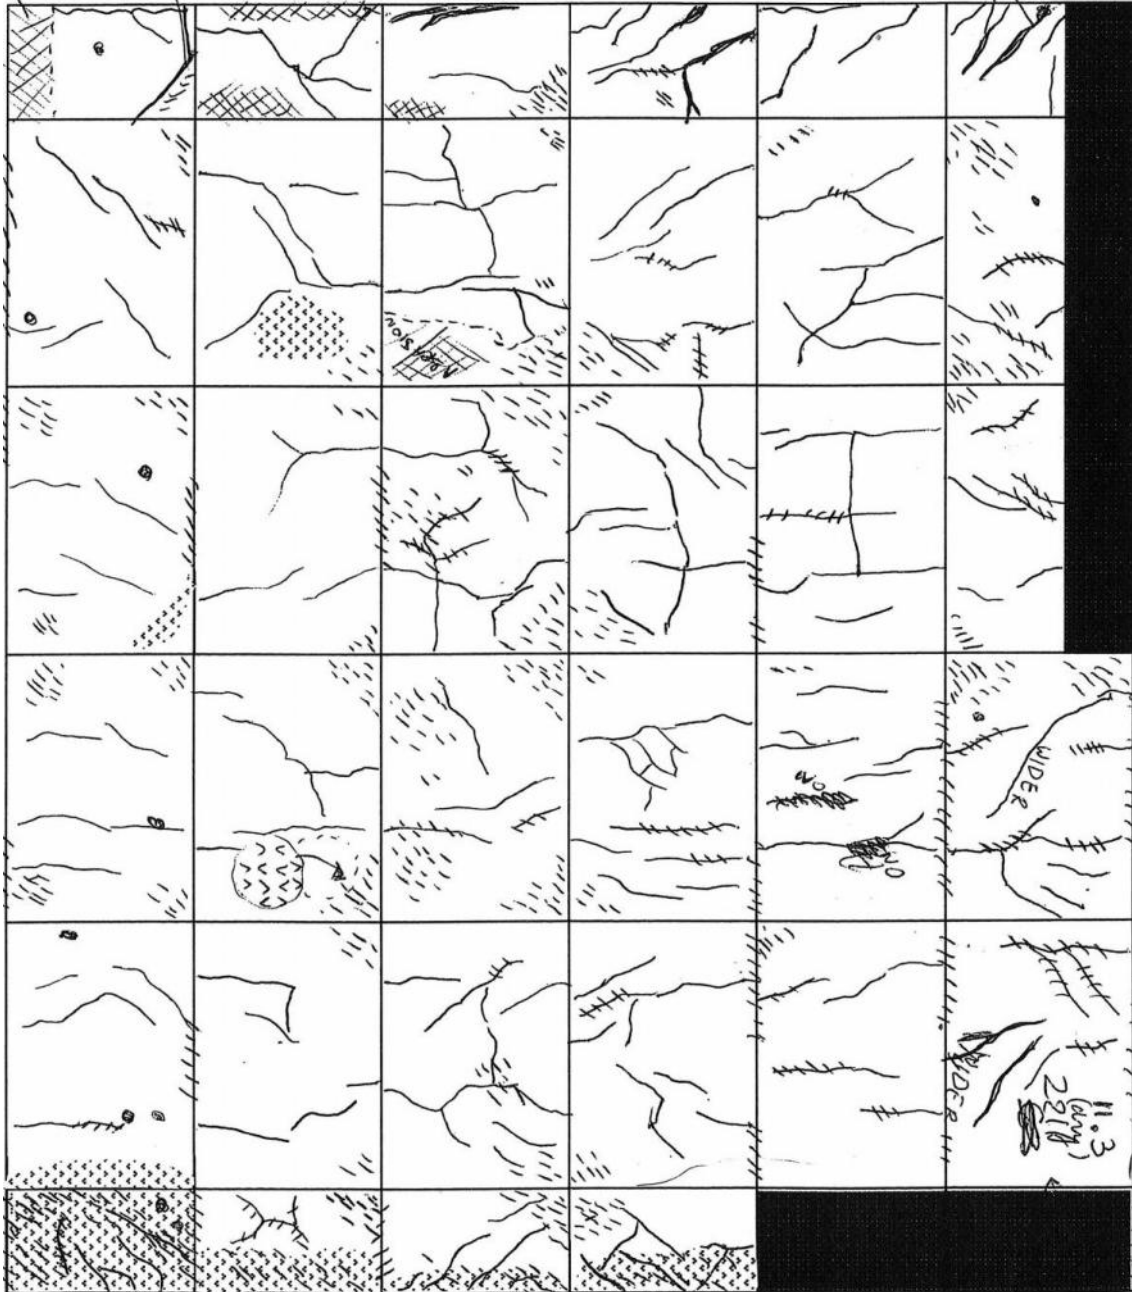
There was an extensive network of fractures to the ceiling panels in both the nave and the south aisle. These were found to be stable, and as the majority are only hairline fractures and not visible from ground level, no filling was undertaken, except to isolated areas of larger loss. The fractures have been mapped onto ceiling plans in Appendix 3.

Reflected view plan of the **Nave Ceiling** showing network of hairline fractures.

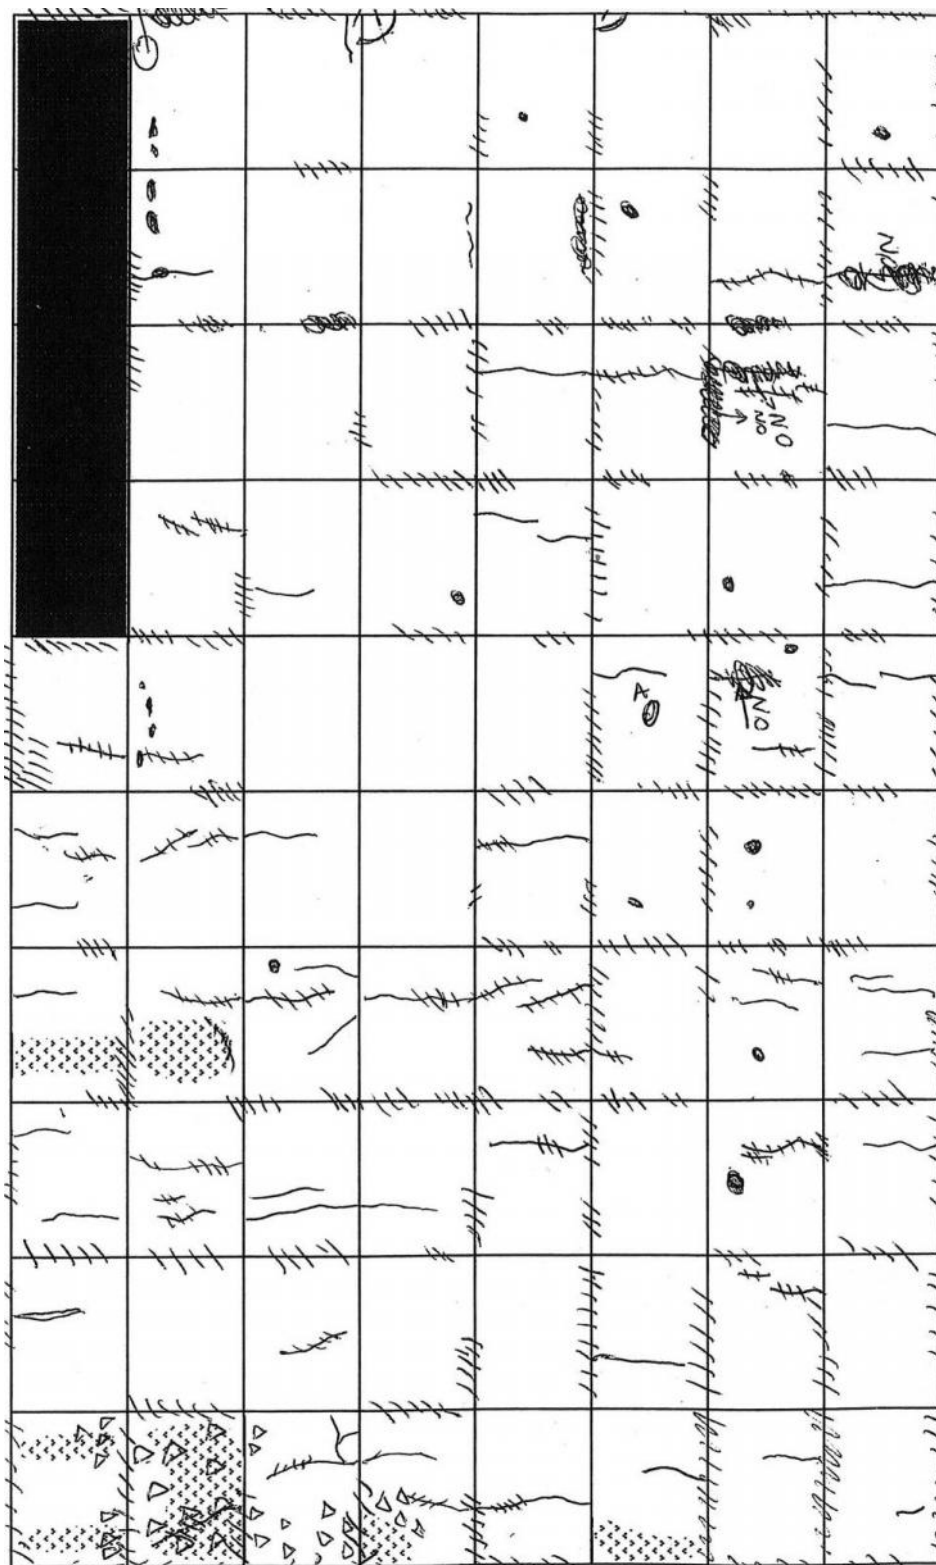
Reflected view plan of the **South Aisle Ceiling** showing network of hairline fractures.
