**Condition Assessment and Treatment Recommendations for the Nave  
and South Aisle Ceilings**

**St Bridget's Church, Brigham, Cumbria**

**Diocese of Carlisle**

**July 2012**

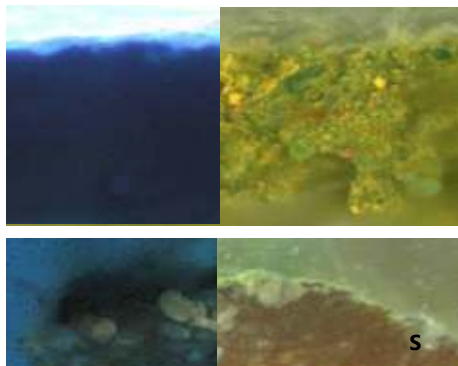
**Figure 8:** Photomicrograph of sample 02 taken from a timber truss in the nave (S denotes substrate).

Only one coat of green paint was evident in sample 02 taken from a timber element to the nave ceiling, see figure 7. The lack of auto fluorescence suggests a distemper paint and the most likely pigment used is terre vert.

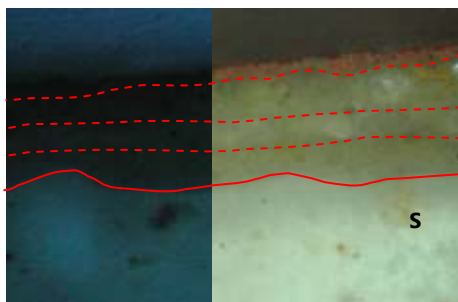
**Figure 8:** Photomicrograph of sample 03 taken from a ceiling panel in the nave. (S denotes substrate).

Three coats of a cream base colour topped by a red stencilled layer were evident in sample 03 taken from a plaster panel to the nave ceiling, see figure 8. The lack of auto fluorescence again suggests a distemper paint.

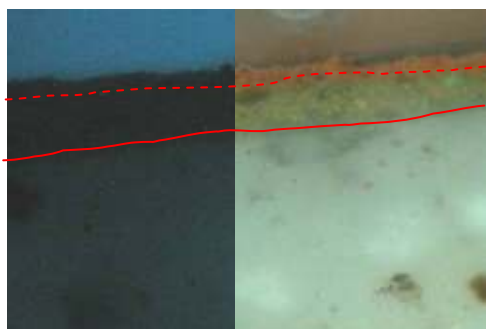
Unlike the sample from the nave ceiling, only one coat of a cream base colour topped by a red stencilled layer was found in sample 04 taken from a ceiling panel in the south aisle, see figure 9.

**Figure 9:** Photomicrograph of sample 04 taken from a ceiling panel in the south aisle.

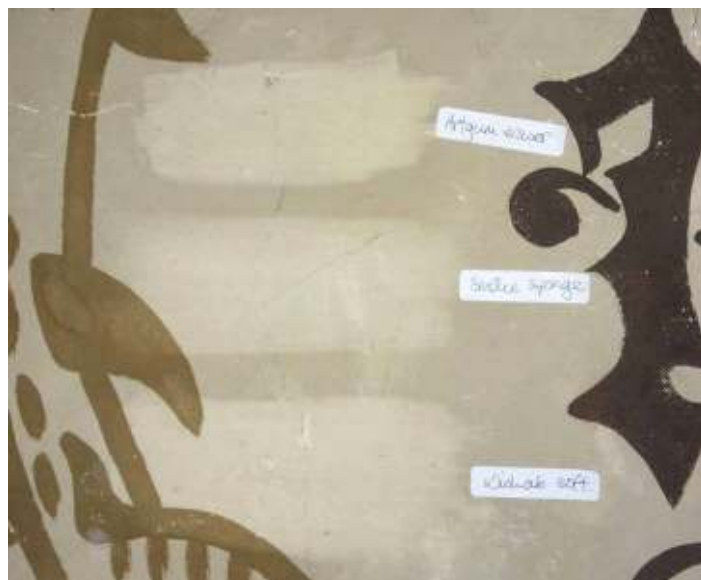
- Smoke sponge (adsorbent silicone sponge): achieved some tonal lift, but with a patchy appearance.
- Wishabs: Cleans quite effectively, and a good tonal lift is achieved. Will help to unify overall appearance of panels. Even where little tonal lift is achieved significant amounts of hygroscopic dirt is removed.
- Artgum erasers (natural gum, non-abrasive eraser with a deep cleaning powder additive): Cleans the lighter colour fields better than with Wishabs but needs to be used locally and with care as it removes some of the more under-bound paint.

**Figure 10:** Detail of results of dry cleaning trials using Artgum eraser (top), smoke sponge (middle) and Wishab sponge (bottom).

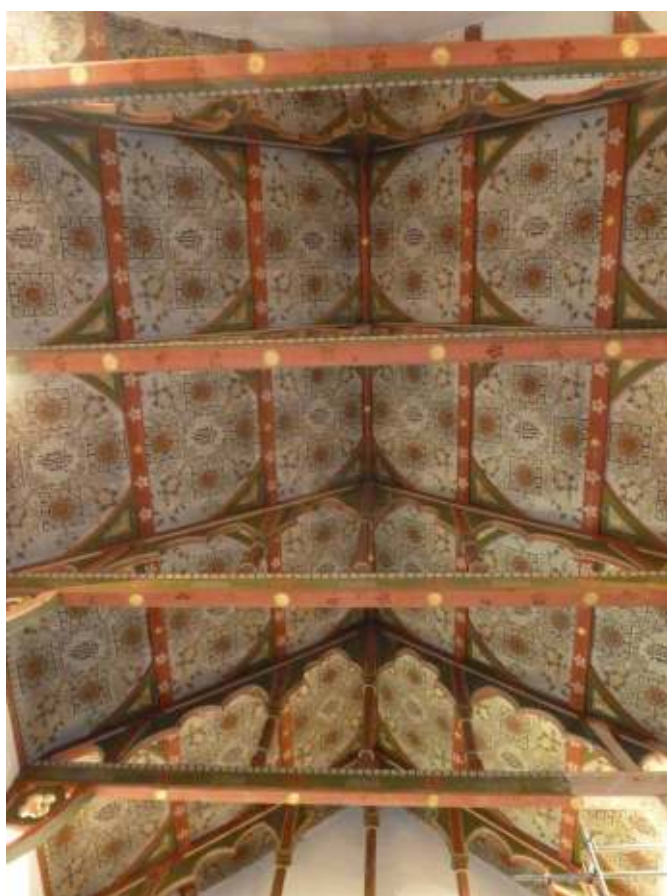
The plaster nave ceiling has 4 bays of full panels and 2 bays (one at each end) of part panels, each bay consisting of 6 panels (see figure 19 and Appendix 2). The 6 bays are separated by 5 timber tie beams, and all surfaces are decorated with stencilled designs and applied gold stars.

**Figure 19:** Overview of nave ceiling looking east. The top of the access scaffold can be seen in the bottom right corner of the photograph.

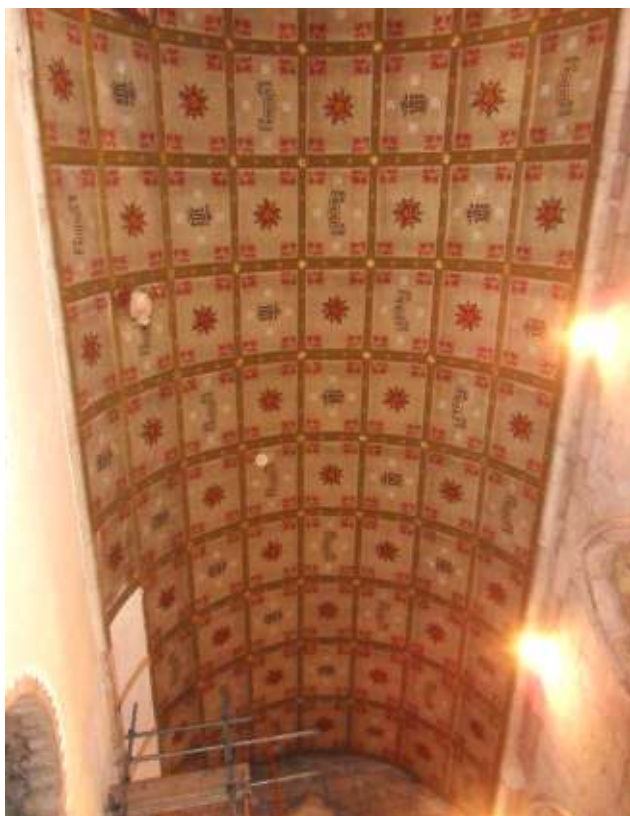
The barrel vaulted south aisle ceiling consists of 80 plaster panels (10 bays of 8 panels) separated by timber frames, with applied gilded stars in the corners of the frames (see figure 31).

**Figure 31:** Overview of the south aisle ceiling. Note the replaced plaster panels in the north east corner, with access scaffold beneath.

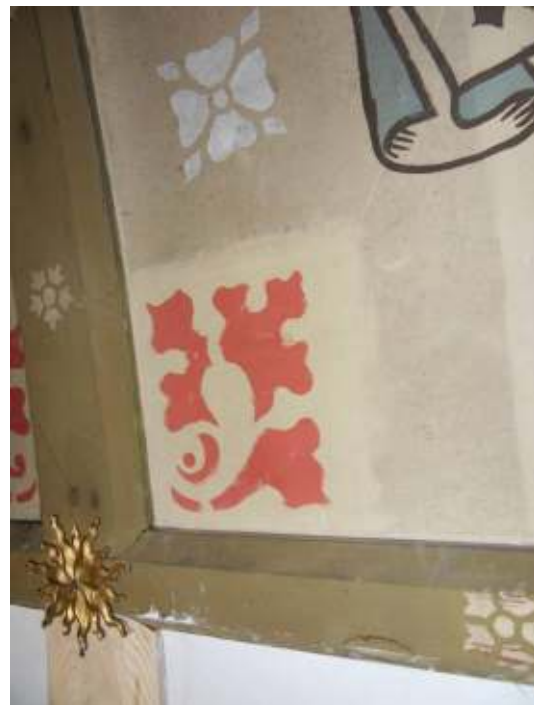
There is a large build up of surface dirt, dust and cobwebs (see figures 36 and 39). The timber frames surrounding the replacement panels have plaster residue on them and some of the original paint has been removed, seemingly when an attempt has been made to remove the excess mortar (figures 35 and 37). There appear to be water run off marks coming down from the beam above one replacement panel, possibly from washing off excess plaster from the beam. There are areas of minor paint loss along the edges of some fractures (see figure 38) and some recent impact damage in the form of scratches (figure 37).

**Figure 39:** Detail of area of cleaning trial using a Wishab sponge.

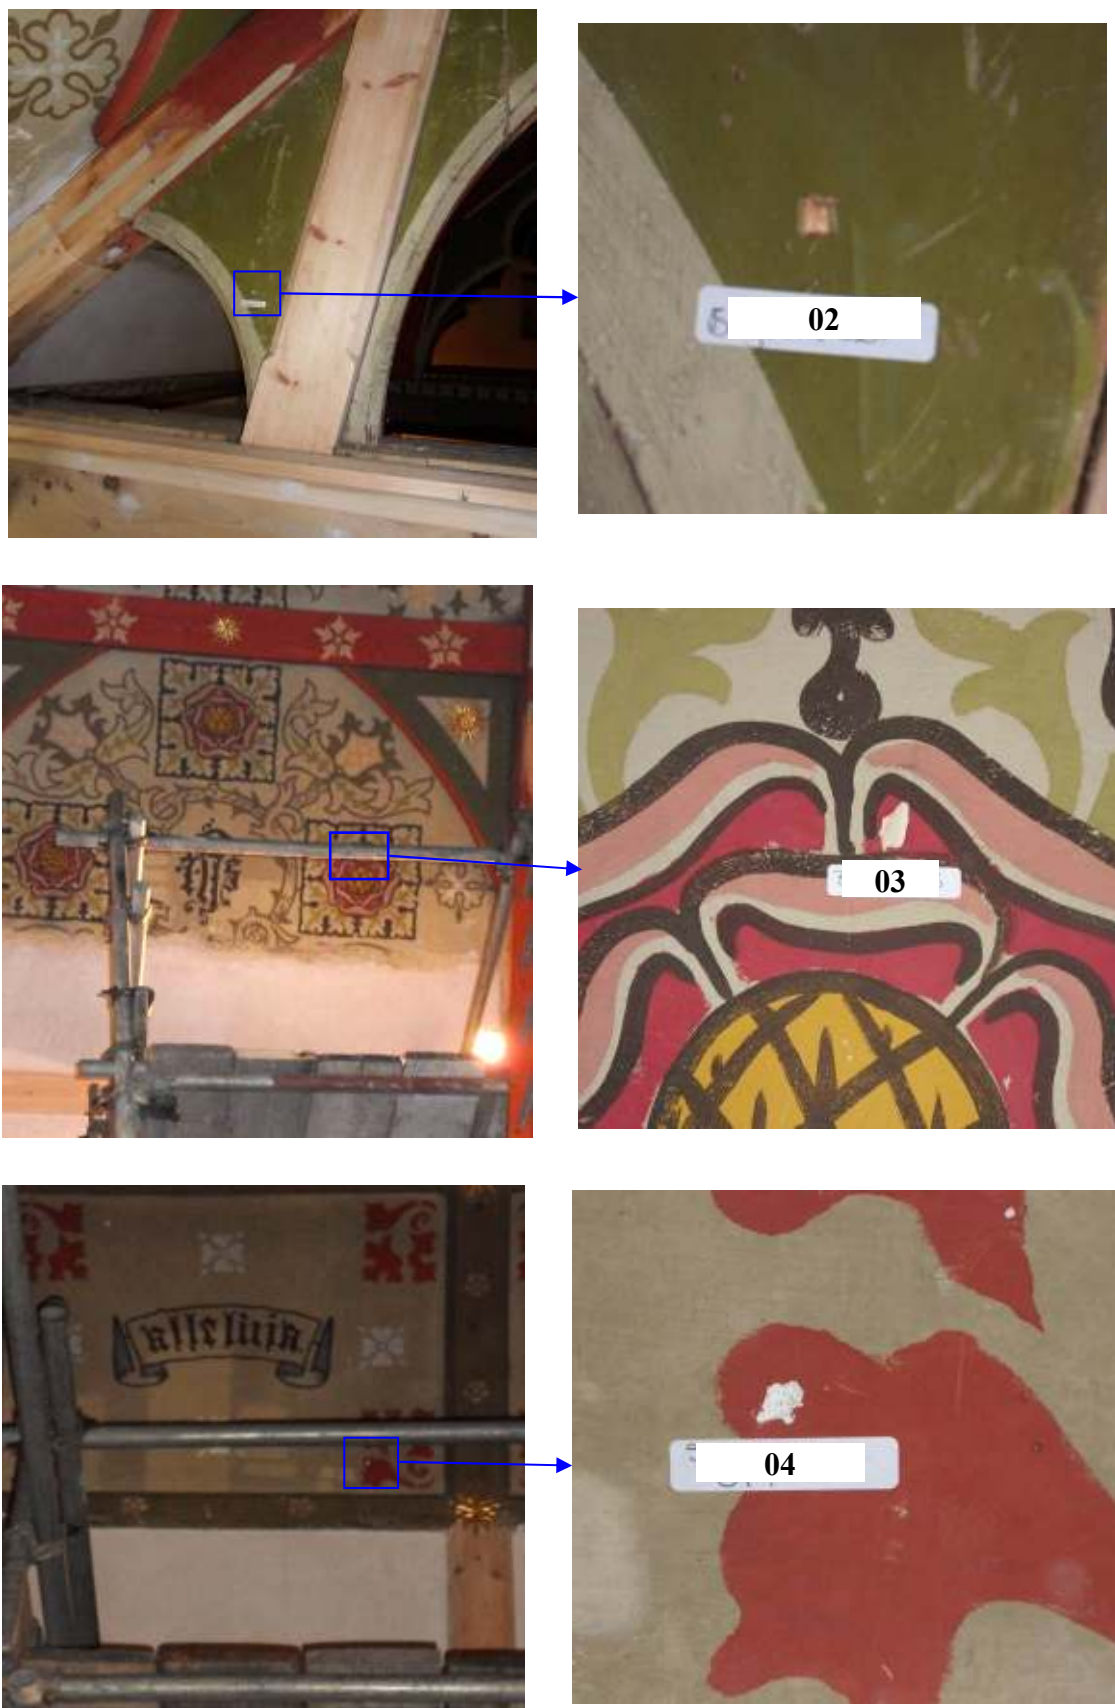
Paint sample locations in Nave (top and middle) and south aisle (bottom).

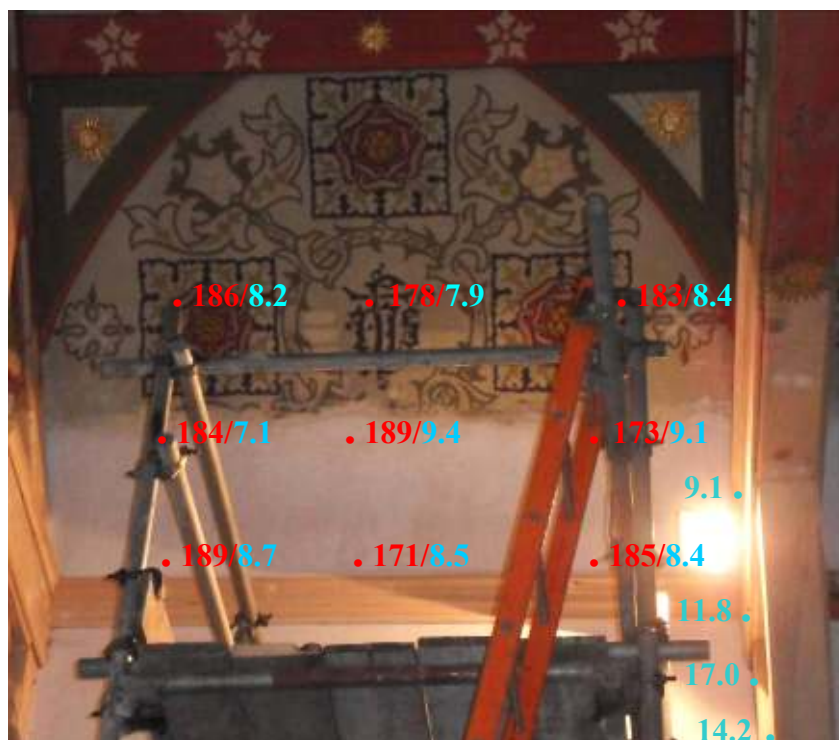
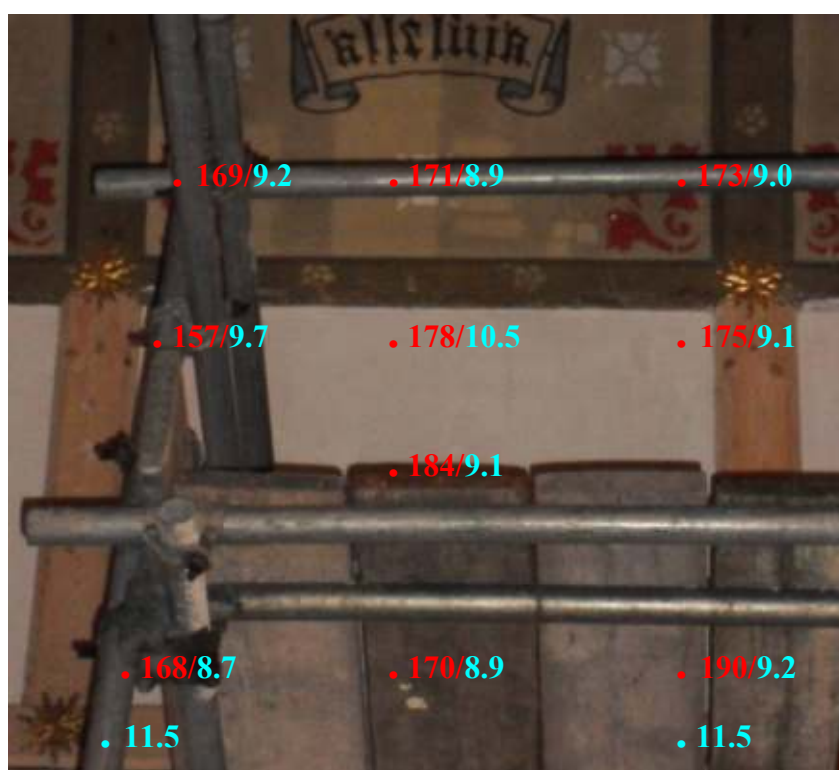
**XX** Capacitance D and **XX** Protimeter readings for the nave ceiling (top) and south aisle ceiling (bottom).
